# Coastwatch Autumn 2012 Survey Results

Republic of Ireland

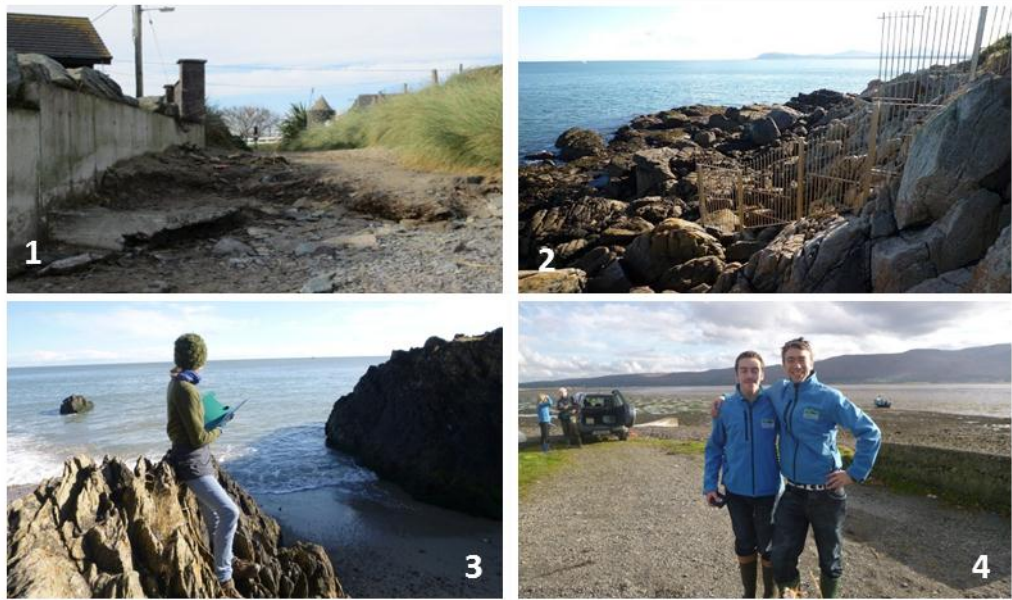
**Image 4 – 1.** Deteriorated access to coast in Louth; photo by Áine Walsh. **2.** “Difficult access” in Dun Laoghaire; photo by Vico Rocks Team. **3.** Can be achieved by locals with good tidal knowledge; photo by Paul Dubsy. **4.** Easy by car as in this Tralee site with regional coordinators from Tralee wetland centre.

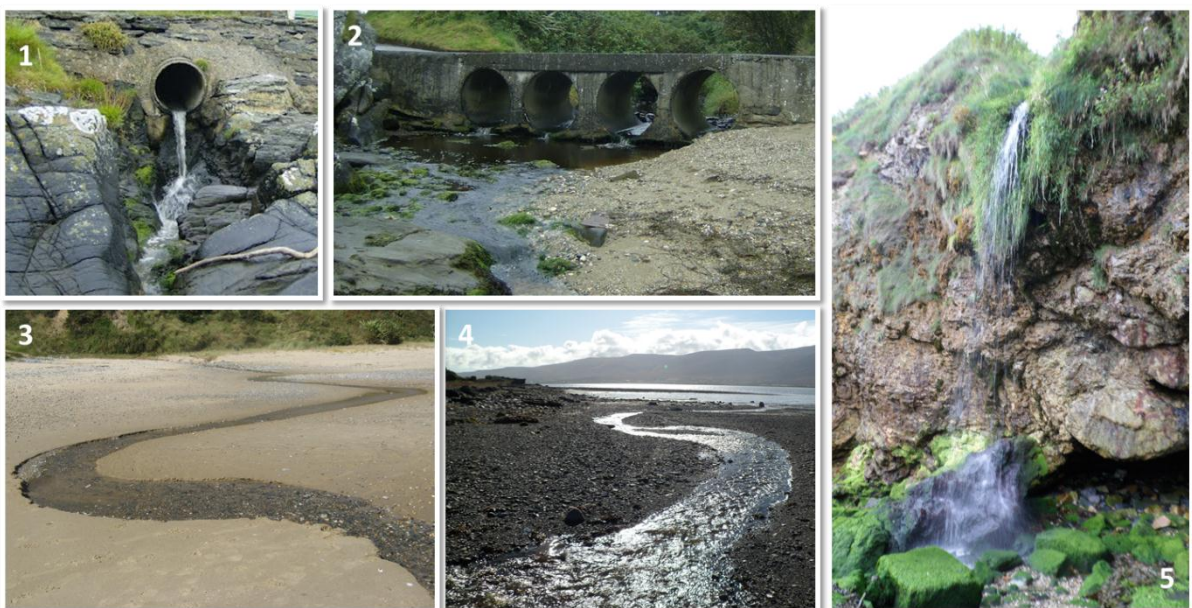
Image 6 - Different types of inflows found on the Survey 2012. Photos by **1 & 2** Celebrate Water (Donegal); **3** Mathilde Stallegger (Ballymoney, Wexford); **4** Martin McLoughlin (Tralee Bay, Kerry); **5** Ángel Duarte (Howth, Dublin)

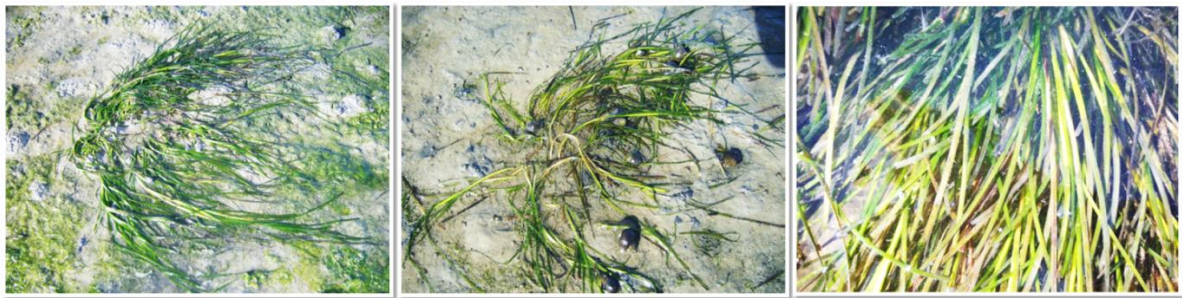
Image 8 - Seagrass *Zostera*. Photos by Karin Dubsky

A third in between length grass is now thought to be a long phenotype of the intertidal *Z. noltii*. The *Z. marina* was reported from 24 surveyed sites (and more in late data not included in the analyses). This follows several seagrass ID training sessions in the last 2 years where Coastwatchers were first instructed by the EPA's Robert Wilkes, who is in charge of *Z. noltii* monitoring for the water framework directive in Ireland. The EPA methods were adapted for Coastwatch surveyor use.

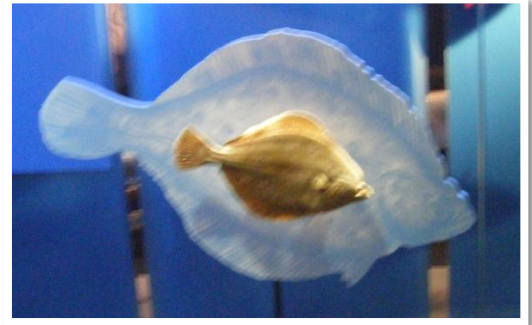
Plaice can grow up to 1 m long and 50 years old, with adults living on sandy bottoms of the European shelf. The picture from an exhibition in the Waddenzee shows maximum size and our fishing size. The *Nephrops* trawl fishery in the Irish Sea takes bycatch of other species, especially plaice but also whiting and cod. Most of that plaice is undersize - i.e. below that of the inner fish in the exhibition panel. These are just discarded. However 2013 may bring major change for the better in the new Common Fisheries Policy (CFP) proposal to be adopted by EU member states.

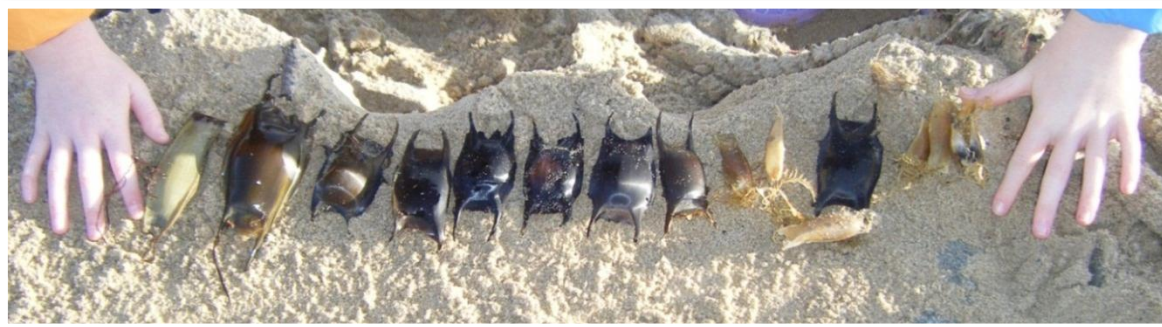
Image 13 - A range of ray, skate and dogfish egg cases on Clones beach, Co Wexford. Photo: Coastwatch archive.

In Ireland we associate the very beginning of the Coastwatch survey period with finding the last empty Dog whelk (*Nucellus*) egg cases stuck like tiny skittles to sheltered rock crevices. The October spring tides can mark the start of 'mermaids purse season', when freshly hatched bunches of eggs of our smallest shark the dogfish and a few single dark ray eggs are swept up into the tide line. This contrasts with the bright rounded honeycomb effect of Common whelk cases, which also roll in on the tide, or stick out of dislodged seaweeds. The main mermaids purse and common whelk egg case season however is not until Christmas and into spring. So survey results are only indicative of possible areas where to search for egg cases later and as an indication of breeding presence if a particular rare species of ray or skate egg case is found.

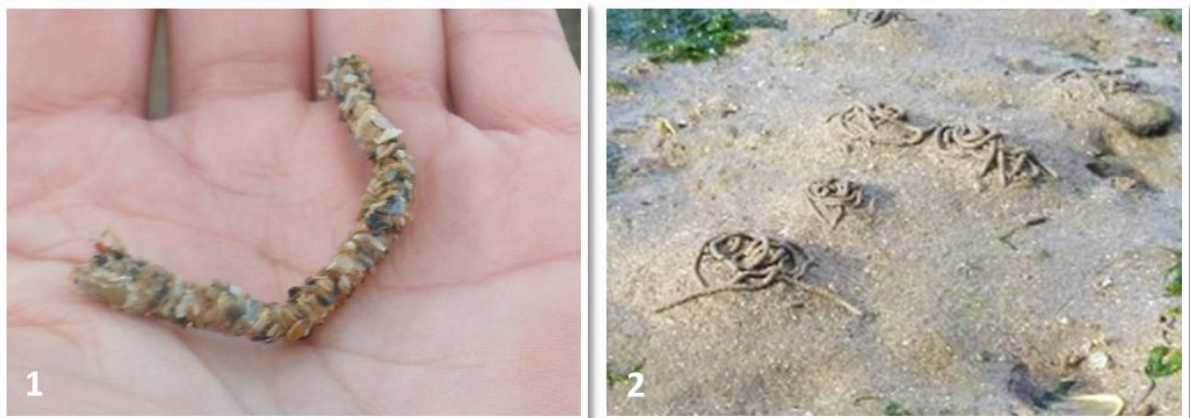
Image 16 – 1 Sand Mason cast, Poulshone, Co.Wexford. Photo by Ángel Duarte 2 Lug worm cast, Crosshaven, Co. Cork. Photo by Mary Mahony.

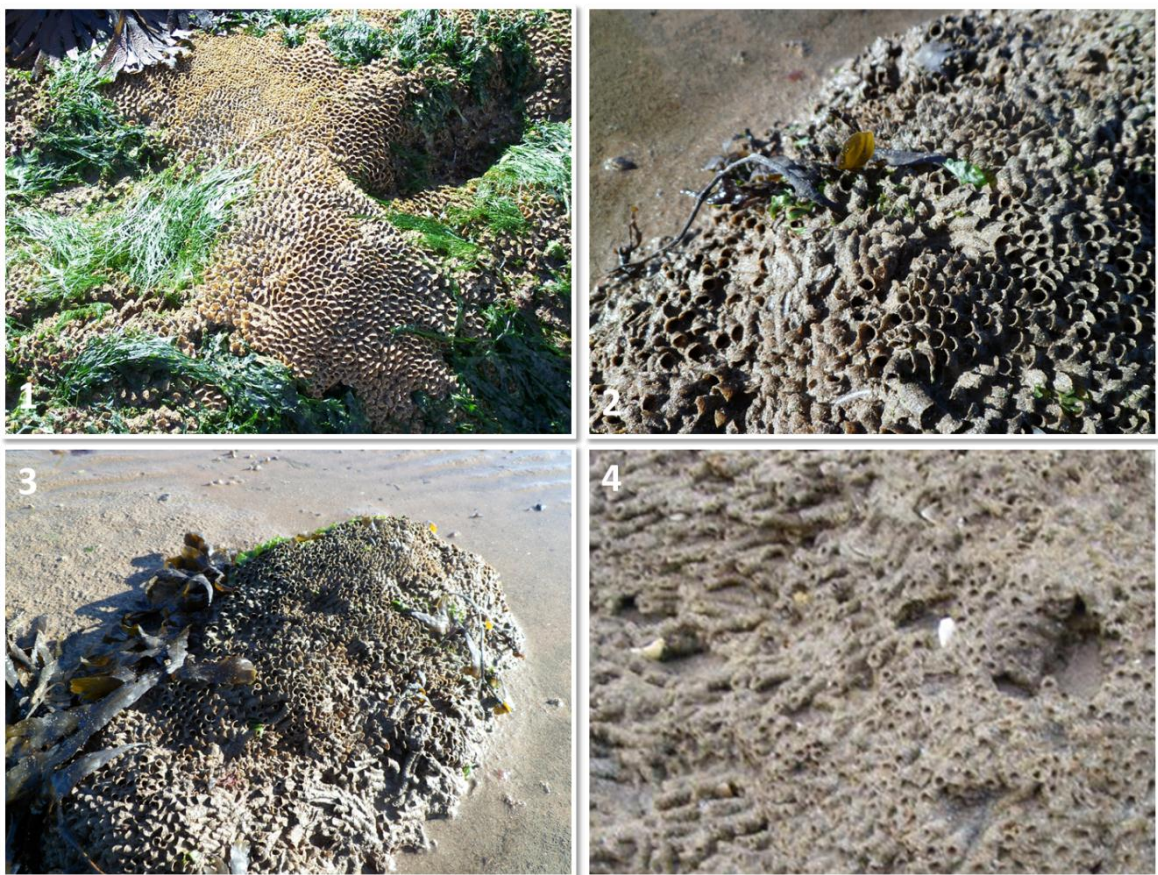
Image 17 - Honeycomb Sabellaria Reefs at Drillistown (Waterford) and Tralee Bay (Kerry), and example of an eroding part of a reef in Lough Swilly. Photos by 1 Patrick Houlihan, 2 & 3 Martin McLoughlin and Ángel Duarte, 4 Mary Butler

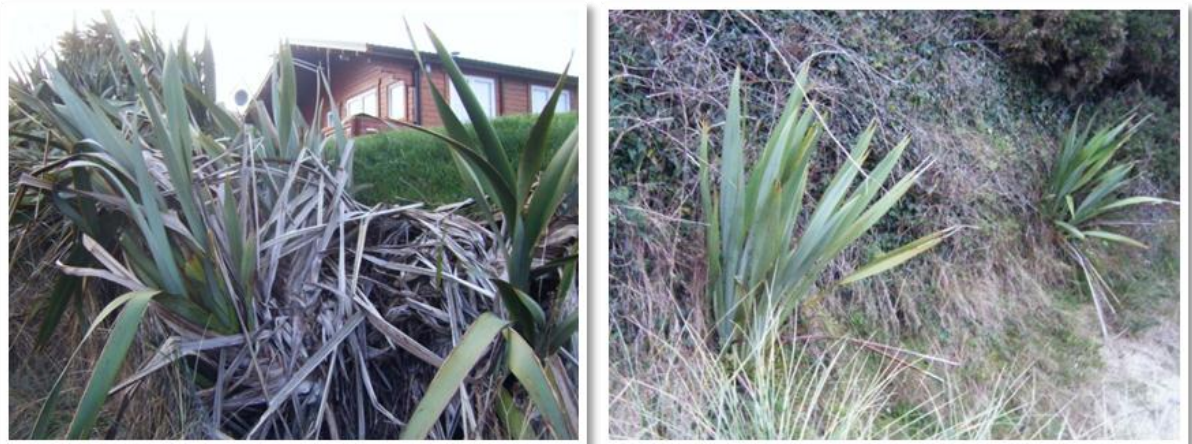
Image 19 – **New Zealand Flax**: sliding down an eroding sea bank at Ardamine Co Wexford ( left) and establishing on remote beach at the ship wreck Ballymoney (right); photos by Karin Dubsy

In County Wexford **New Zealand Flax** is spreading noticeably in the north of the county. It is establishing from seed and discarded plants and new plants are seen on pristine vegetated sea bank shores with no housing within miles as midway between Clones and Ballymoney. In a 2 km stretch between Polshone and Ardamine the plant was introduced as shelter around holiday homes, but has spread into a flax thicket right down to the foot of the seabank from where it can be carried to other coastal sites. In the high value Natura 2000 site grey dune at Tinnaberna where a few plants were set and just grew taller decades ago, a significant spread has been noticed in the last 4 years.

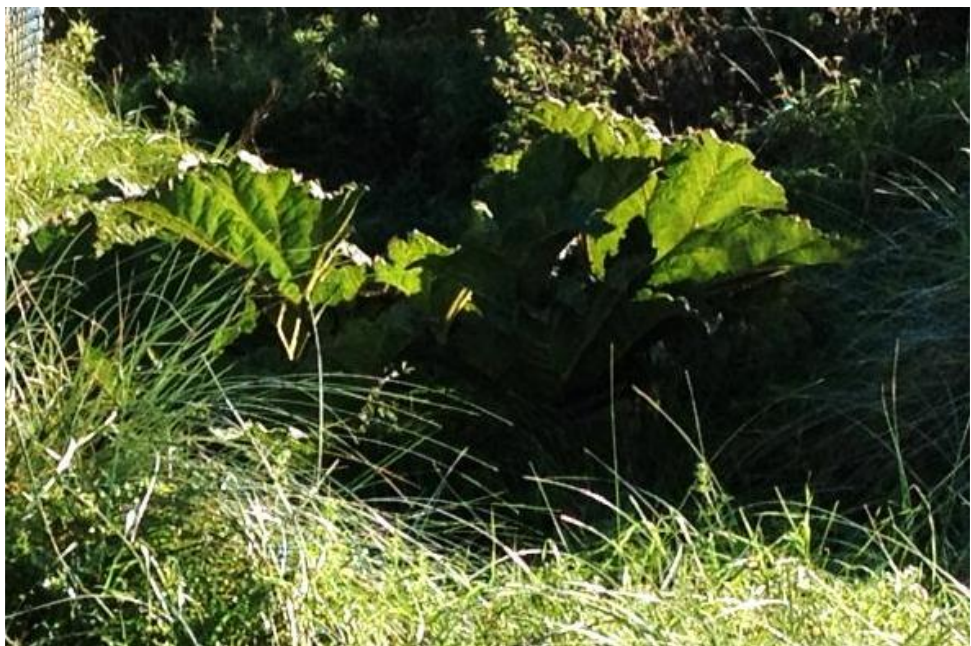
Image 20 - *Gunnera tinctoria* at Glassilaun beach, Connemara. Photo by Rory Keatinge

Giant rhubarb was noted in an inflow to Glassilaun beach just south of Killary Harbour in Galway. It is a well-known invasive in the area and has been a serious problem north of here on Achill Island. It can survive and spread through its rhizomes making it difficult to eradicate. Due to the size of its leaf it can leave other plants in the shade making it very difficult to compete with. Although common in parts of Connemara it is new to this survey unit.

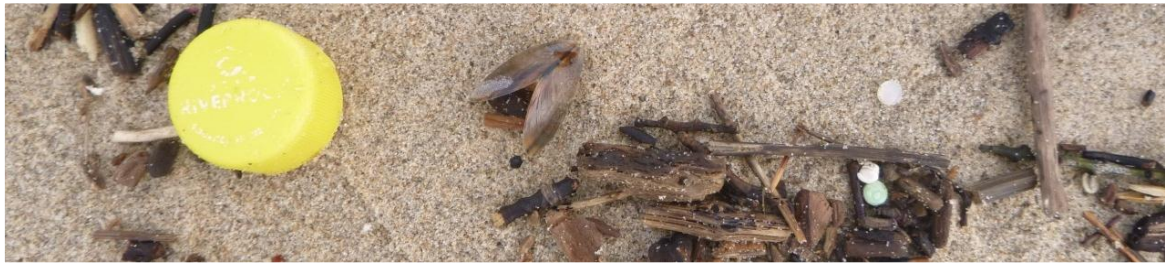
Image 22 – A lid, hard plastic pellets and polystyrene bead – typical small and micro-litter. Photo Karin Dubsky

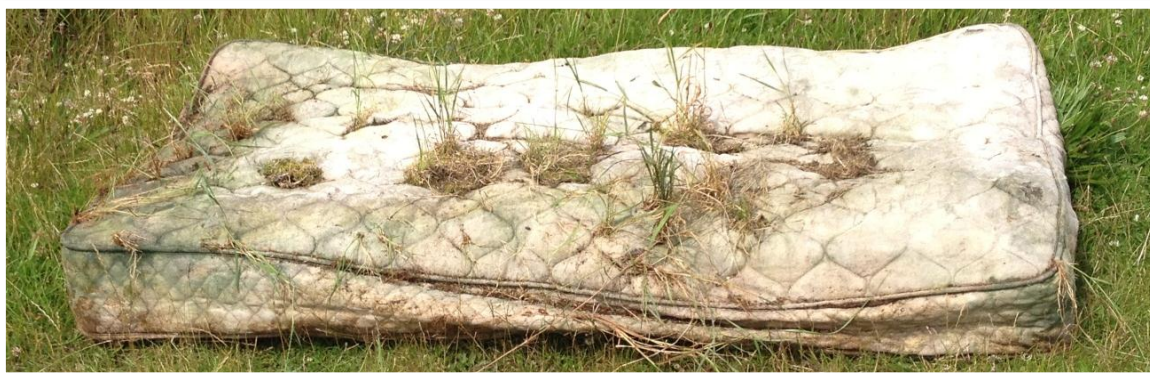
Image 23 – Mattress found in the Boyne estuary at Stagrennan Polder. Photo by Boyne Coastwatcher

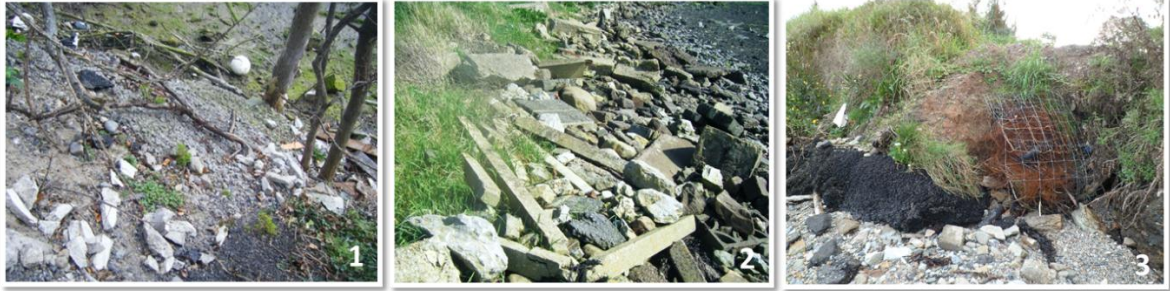
Image 24 – **1** Construction waste dumped at the tidal channel edge, beside Booterstown station, Co. Dun Laoghaire; **2** Dungarvan town coastal infill (Natura 2000 site); **3** Tarmac and other waste land claim at Whitecastle, Lough Foyle.

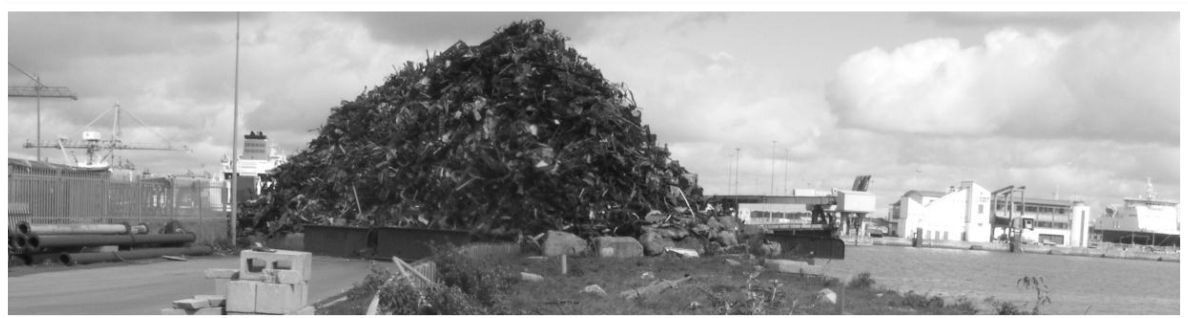
Image 25 – So close to the water’s edge - metal crushers. Ringsend, Liffey estuary.

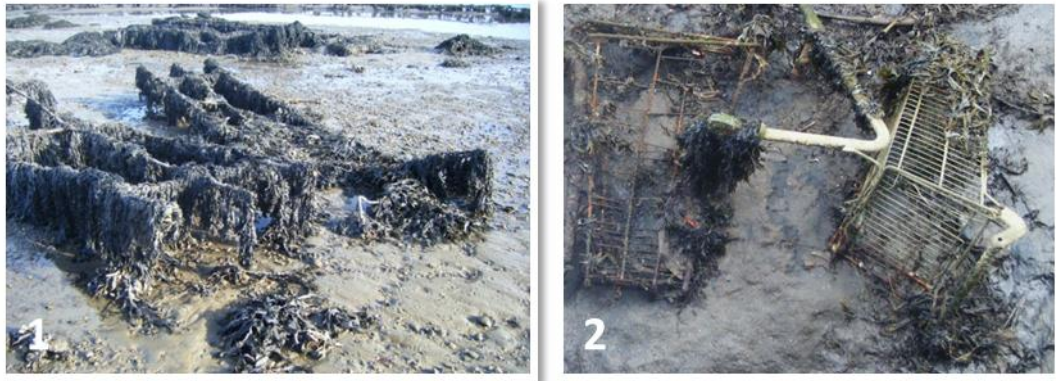
**Image 26 - 1** Silting around empty iron oyster aquaculture trestles in Bannow Bay; **2** Supermarket trolleys in the Liffey.

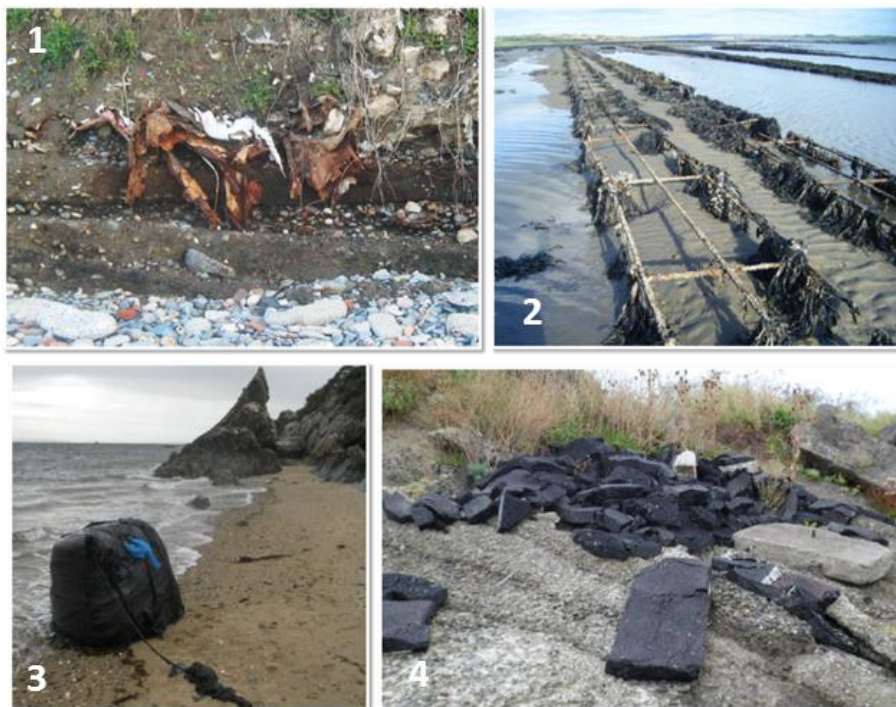
**Image 27 - Large waste items found by surveyors during the Coastwatch Survey 2012. 1** Eroding Bray town landfill site, photo by Lucy Dillon, **2** Aquaculture farm trestle, **3** A new use for silage wrap? Household refuse at L. Foyle, photo by Trish Murphy and **4** Tarmac or asphalt at Sandymount, Co. Dublin; photo by Ángel Duarte

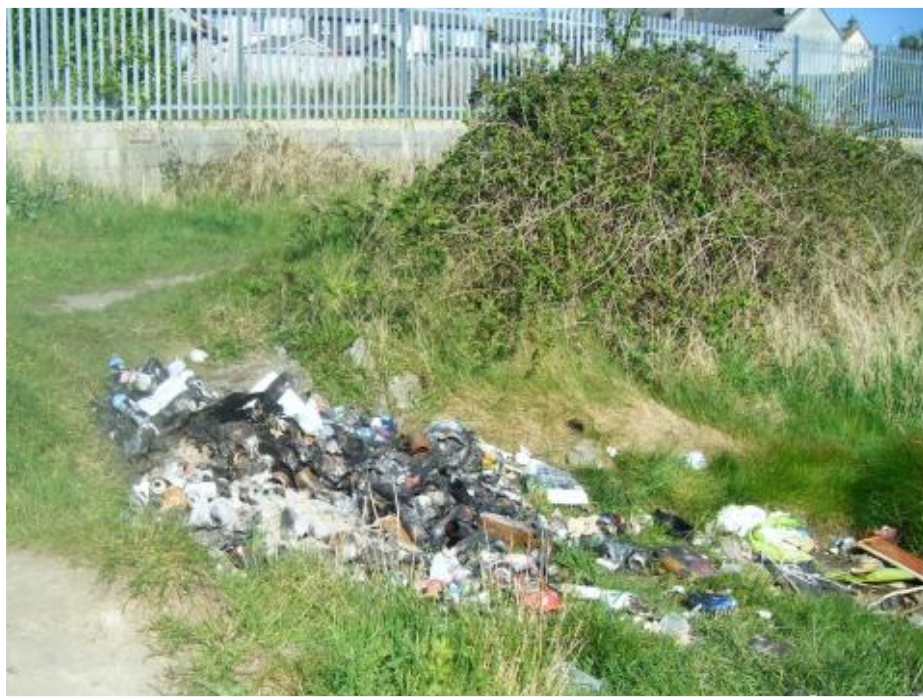
Image 28 - Dump and burn site at the edge of the saltmarsh Ringnasilloge, Dungarvan, Co Waterford.

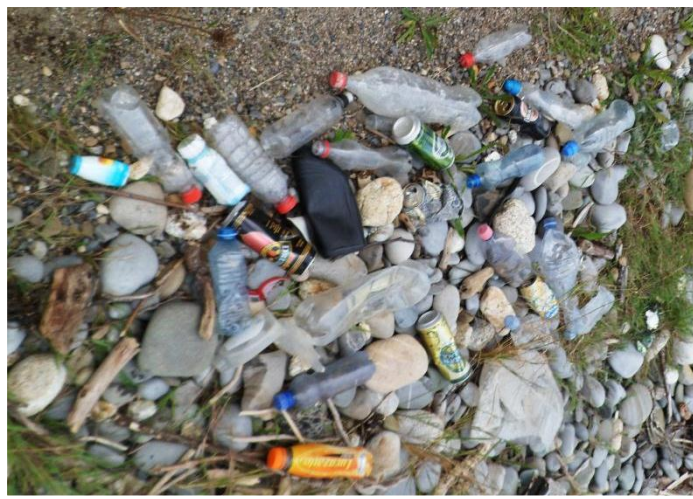
Image 29 – Littered area in Killiney, Co. Dun Laoghaire Rathdown; photo by Ester Moncho

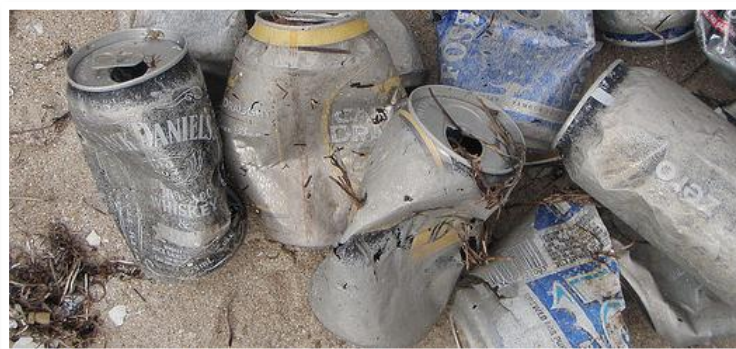
The **can count** has improved over the years and is now down to just under 12 cans/s.u. Apart from lower sales of drinks in cans than in bottles, a contributing factor may also be the use of a lighter tin like material which breaks apart in the centre. The can pieces, while sharp and dangerous for bare feet sink into sediment much faster than the old whole cans and may not be noticed as can litter. Some follow up studies would be needed to clarify the new can's life cycle on the shore and fate of the pieces.

Image 30 – Accumulation of cans in Sandymount, Co.Dublin. Photo by Ángel Duarte.

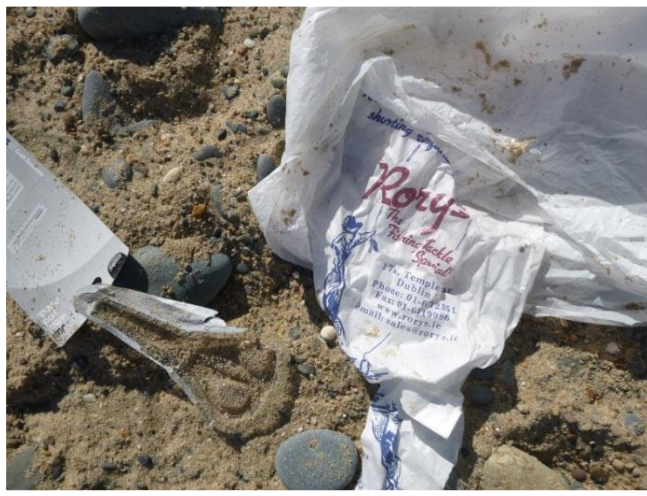
Image 31 – Remains of a plastic bag.

The remaining shopping bag litter appears to be either unidentifiable or associated with two sources – drinking locations and angling spots. Cans bought in off licenses and supermarkets for outdoor drinking appear to be carried to the shore in plastic bags. Some users diligently collect the empty drinks containers, put them back into those same plastic bags but then leave them on the shore. Angling bait is sold in plastic boxes which are then placed into plastic bags, some of which are branded as seen in the photo above from a Dublin shop bag. Inspiration how to address this might come from those who sell the tackle?

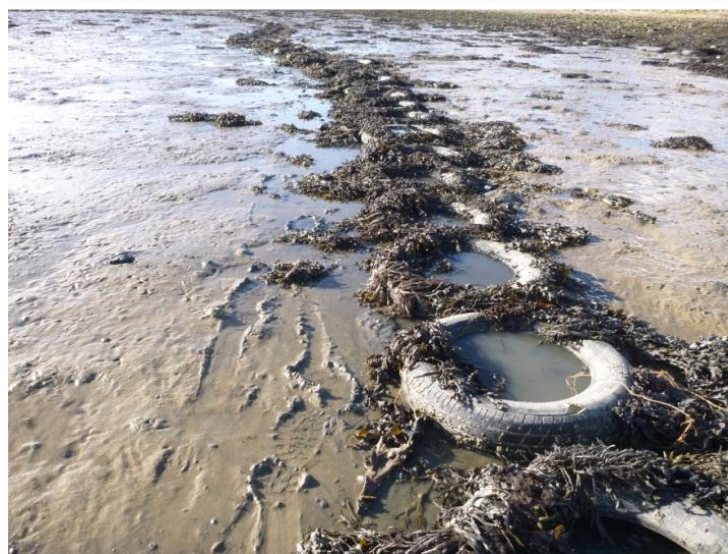
Waste tyres were found in almost a third of survey unit (31%) but were very much clustered with nearly half of the 699 counted in Bannow Bay. This is one of several known Natura 2000 sites where the car tyres are placed into the intertidal to catch peeler crabs. As the crab gets ready to shed its old shell and grow a new one it appears to favour the shelter of the warm dark tyre over rocks and seaweed. The lines of tyres then become a magnet for crabs and may reduce the local crab population significantly if the traps are worked over a large area and emptied often enough. The effort also reduces mudflat habitat and frequent checking adds to bird disturbance in winter.

Image 32 - Tyres set in Bannow Bay to catch peeler crabs; photo by Paul Dubsky.

Car tyres are a priority waste stream under EU waste law and are to be kept out of landfill sites. The free delivery of the tyres to the shore by some garages incentivizes addition of more tyres as old ones silt up. It is strongly recommended that this unregulated practice be scrutinized and regulated, especially as it is found in Natura 2000 sites.

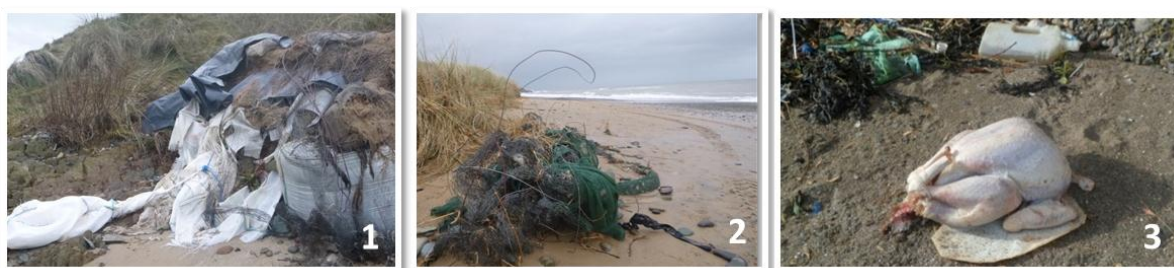
**Image 33 – Other Waste and litter included** **1** Official sand fencing remains on Kilpatrick beach Co Wexford and **2** private sea bank erosion control in the next survey unit (photos by Kelly family); **3** an oven ready chicken on Dollymount beach, Co. Dublin; Photo by Ángel Duarte.

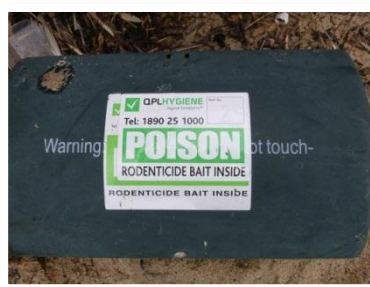
**Image 34 -** A Ballymonee shore surveyor photographed **rat poison boxes** including this one, which had been kept behind the lifeguard hut, but forgotten when that was moved at the end of the bathing season.

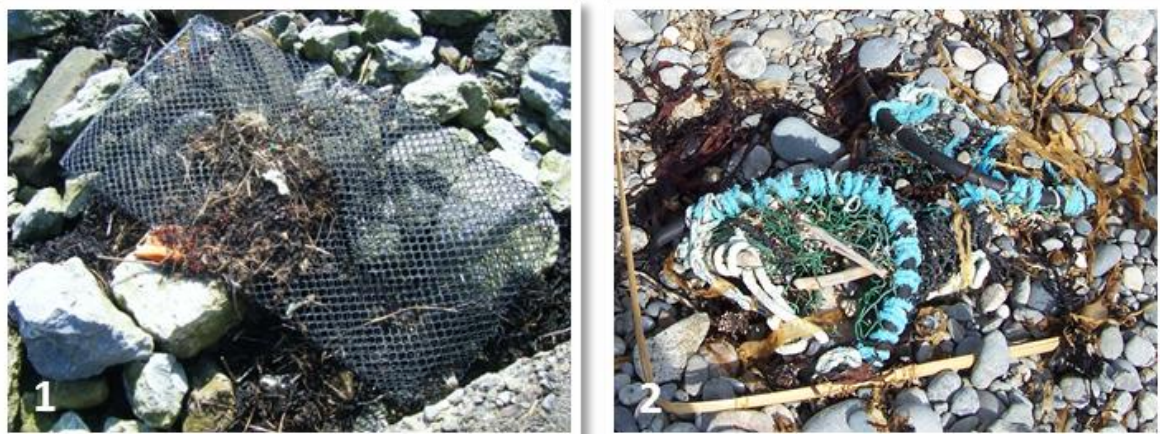
Image 35 – **1** Netlon oyster bag at Woodstown, Co. Waterford, photo by Andrew Cox **2** Lobster pot at Drillistown, Co. Waterford, photo by Patrick Houlihan

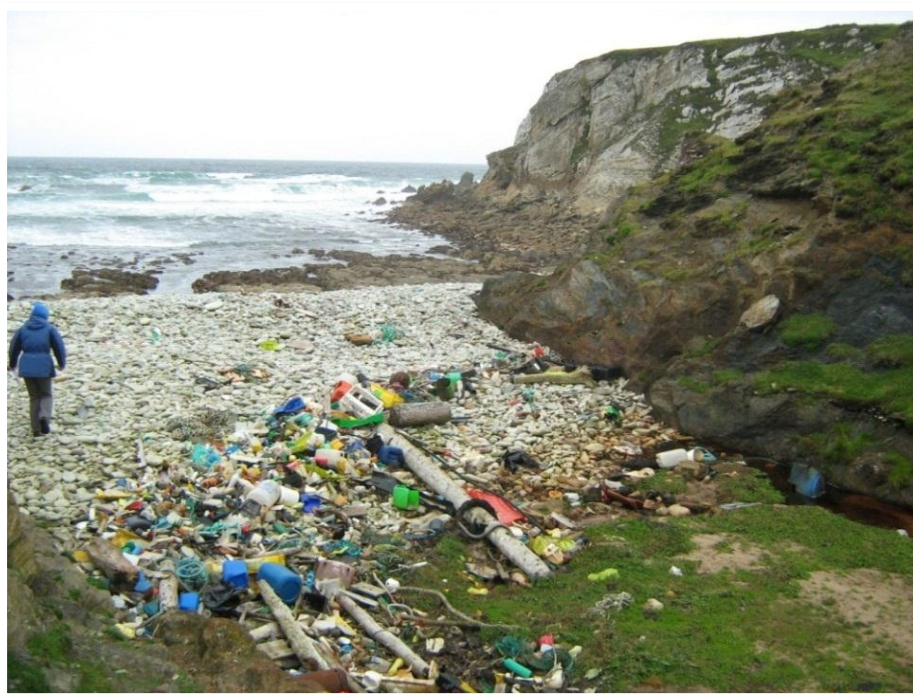
**Image 36 - ‘A picture of Aghleam beach Mayo, my biggest supply of plastic’, by François Gunning.**

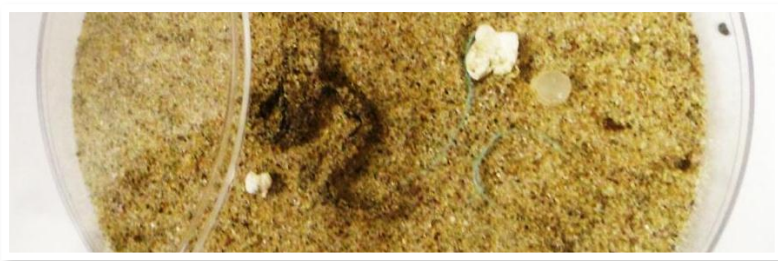
The large amount of plastic filaments was noteworthy and links back to degradation of fishing gear and other rope and twine. In the case of Polystyrene, degradation of bigger pieces of the foamed material found in 35.7 % of the survey units and observed as second most common micro-litter in this pilot project points to the need for material substitution.

Image 37 – Micro-plastics found during Coastwatch micro-litter pilot study.

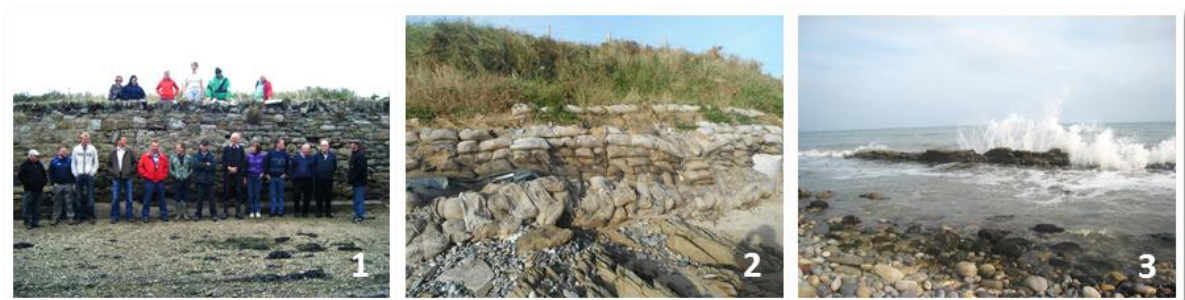
**Image 41.** **1** Local people ready to participate in sea wall restoration and maintenance at St Kierans, Co Wexford; photo Karin Dubsky. **2** Erosion control at Kilpatrick beach; photo by Breda & Andy. **3** Old sea walls at Shanganagh (Co. Dublin); photo by Rory Keatinge.
