COASTWATCH AUTUMN 2015 SURVEY RESULTS ALL IRELAND

Version - June 2016

This is a draft of the Coastwatch Results 2015 and it is not a complete version of the Report

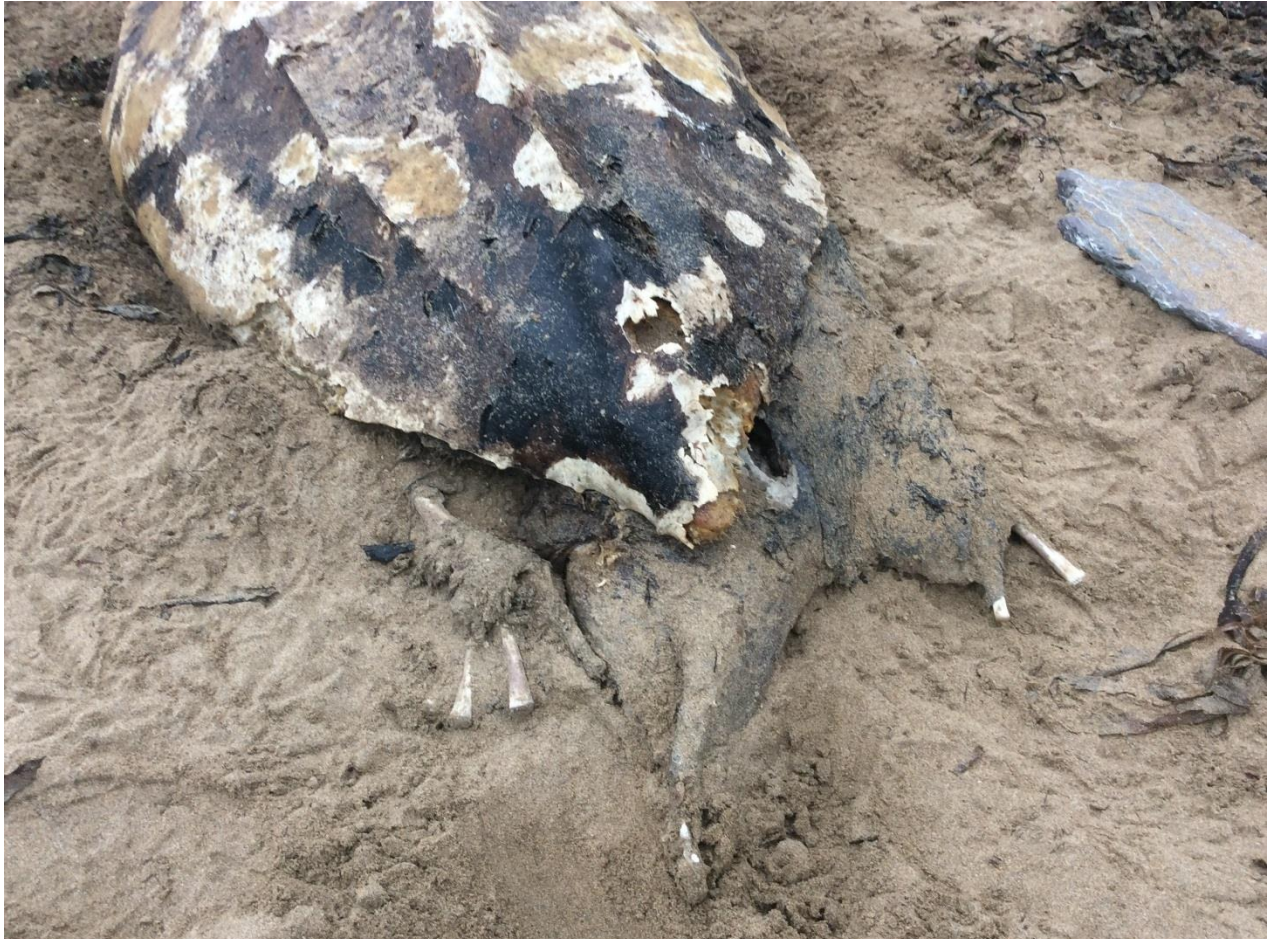
Figure 1 Leatherback turtle found in Ballycronin by Mary Loby.

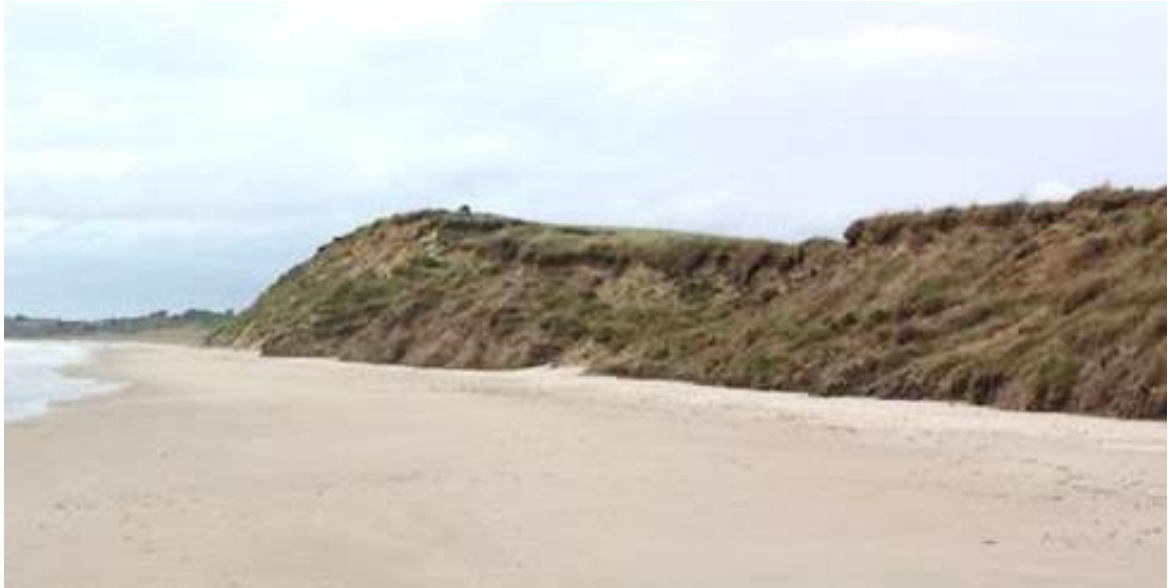
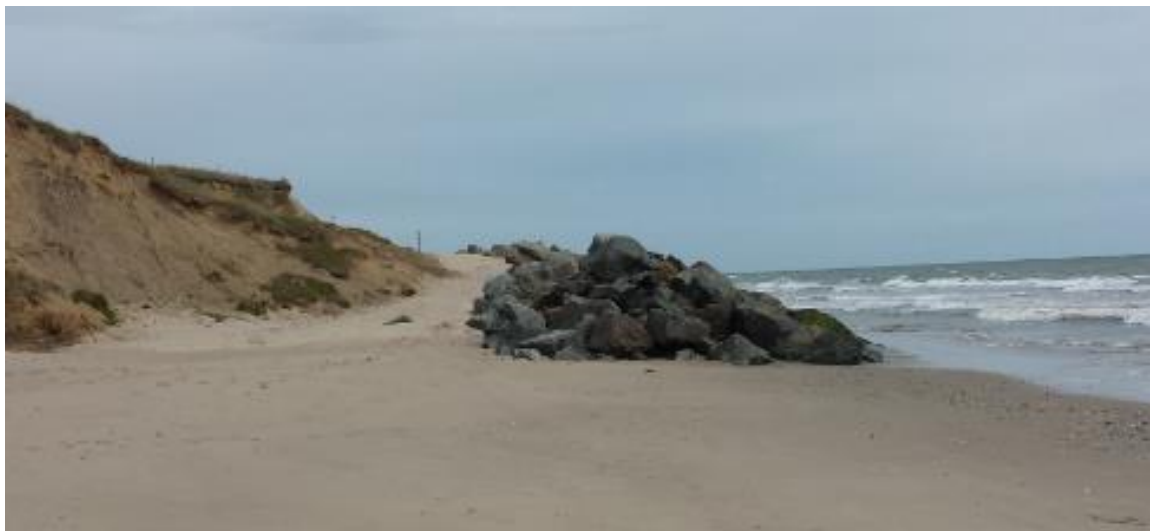
Now focussing on dunes around the Republic of Ireland, we overlaid Coastwatch reports of dune in the immediate hinterland and/or splashzone on the latest NPWS dune habitat maps (Article 17 reporting data, 2013) [map XX](#). This confirms that Coastwatch surveys which were carried out in areas officially recorded as dune, were generally reported as dune – although there were exceptions as in Dublin bay around Sutton dinghy club and south of Sutton cross where the dune fringe is now so small that it was discounted and at Ballyconniger Co. Wexford where the dune has now eroded and all that is left is a row of rock armour which was once put at the foot of the dune and a sand cliff with farm grassland and caravan park hinterland - see photos below/

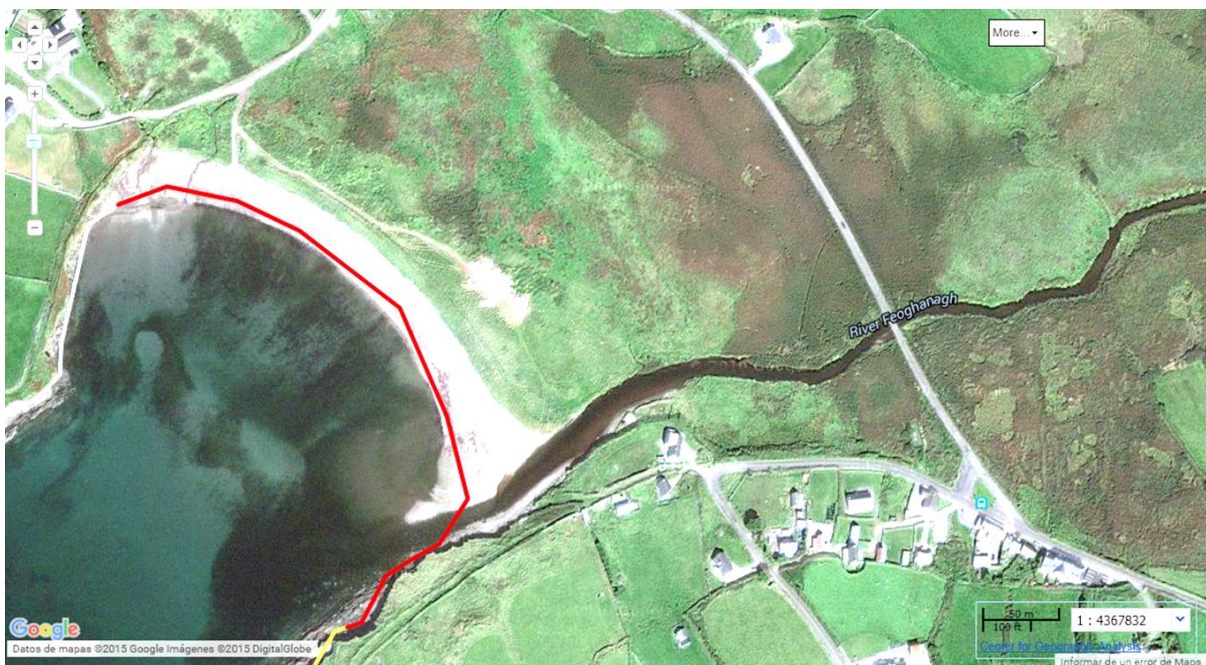
Figure XX Baile An Reannaigh Co Kerry 8 – 10 – 125 – 10 Co Kerry a small dune outside the NPWS dune data base.

Moving around to the West coast, The pocket dune of Baile An Reannaigh 8 – 10 – 125 – 10 is more of machair character according to surveyors who noted that the flat dune gently slopes back to boggy land. The site is under pressure from sand removal which is taking place both on the beach and as is seen in satellite image in an area of vegetated older dune.

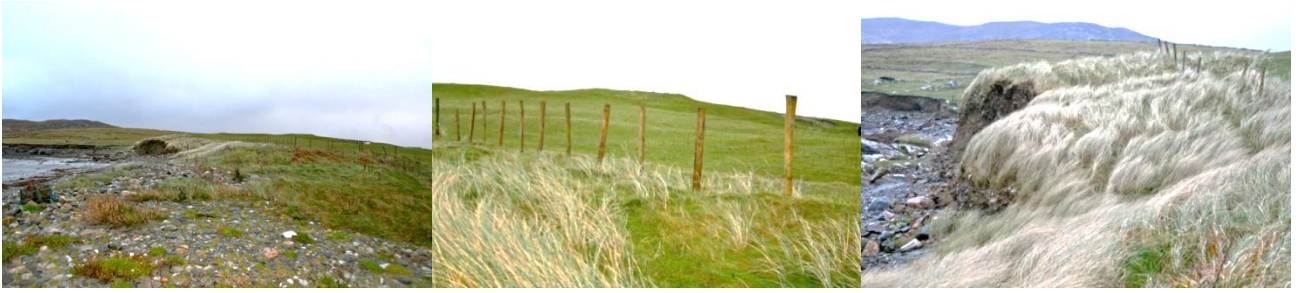
In Galway Polly Dolan recorded dune vegetation outside the NPWS map list behind and sent transect photos from shore, over drift line, to dune to tightly grazed dune grassland vegetation which ends in a boggy wetland. – see below. There are Neolithic settlement remains on the site.

Figure XX Salena beach Co Galway with old dune hinterland and photos 1-3 from shore to downward sloping grazed field to wetland

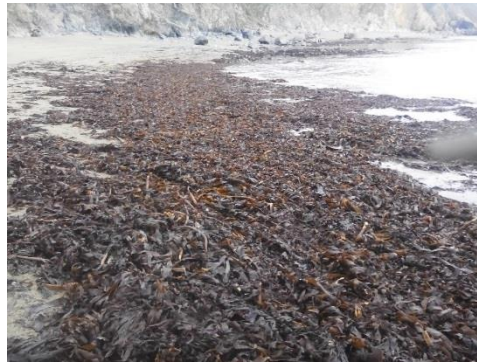
Figure 4 Brown seaweeds live and dislodged Co Waterford (Photo (L) XX and (R) Paddy Houlihan

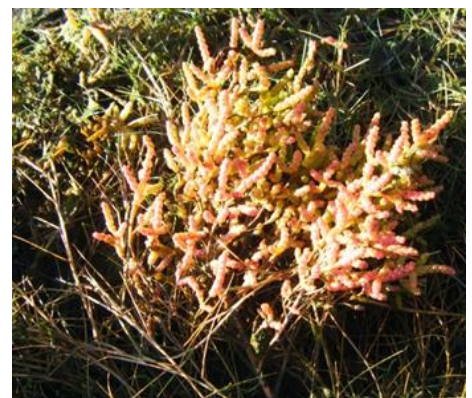
Glasswort (*Salicornia*) is a hand high fleshy edible plant, which usually pops up from seeds on the upper mudflats and low saltmarsh in May. By the time the autumn survey is in progress the plants are turning the colour of autumn leaves.

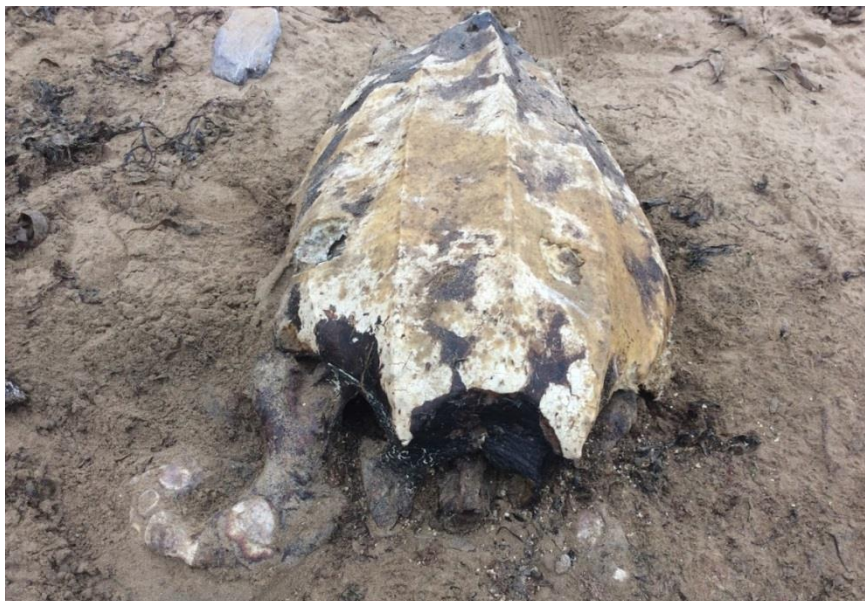
As well as the species counted above two headless leatherback turtles found – one in Cork by Mary Looby's group and one in North Wexford by local surveyors (names withheld) and verified as adult Leatherback sea turtles from flipper bones by Martin L. Zoology dept TCD when brought Coastwatch coordination.

Figure 5 Remains of Leatherback Turtle found swept up in Cork by surveyors, reported by Mary Looby.

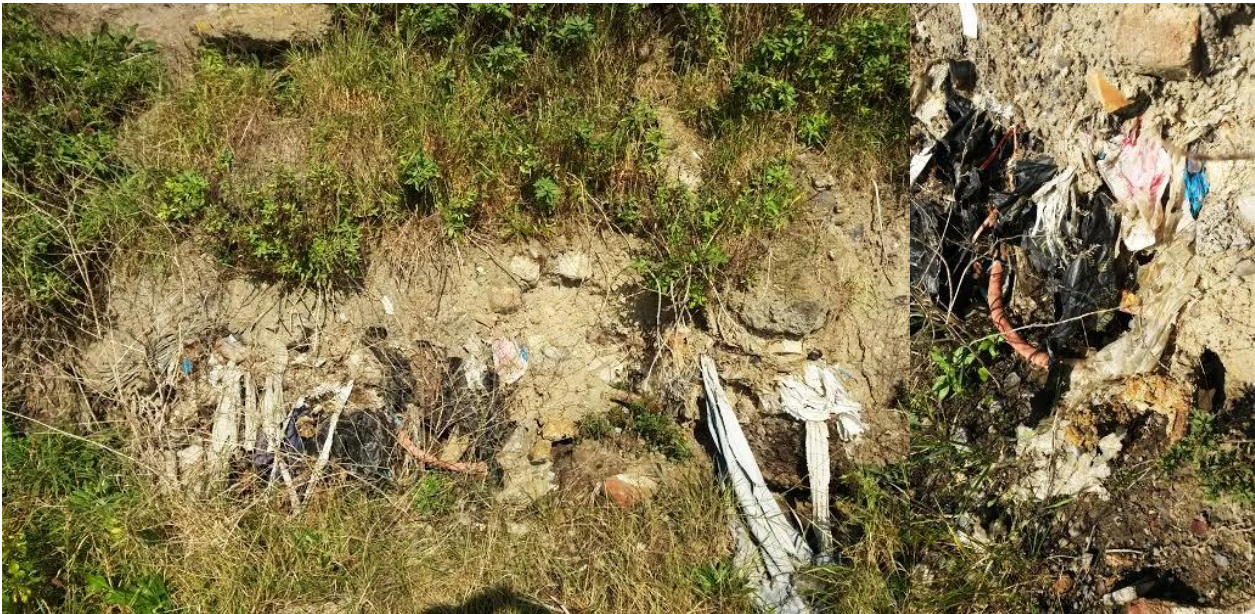
Image 2A and 2B- Showing the extent of landfill materials being dragged out to become marine litter as a result of wave action.

Inappropriate erosion control wetland infill, vehicle tracks, bait digging without backfill and aquaculture were the most widespread shore damage types noted. Most construction waste dumping as erosion control such as at Dublin's Ringsend Nature Park is historic rather than recent, but that still requires attention and in follow up work Coastwatchers have explored options with more secure erosion control, natural look and biodiversity enhancement. In Youghal a wetland behind seabank between old landfill and harbour has received more waste and in Co Clare an infilled wetland North of Lahinch will hopefully soon be restored as infill was found to be illegal. In Bray, the old closed dump is still falling into the sea. Aquaculture installations were reported to now extend along approx. 15 km of shore on the Donegal side of the lough. These are unlicensed and causing visible seafloor damage as well as increasing the risk of further Gigas oyster settlements.

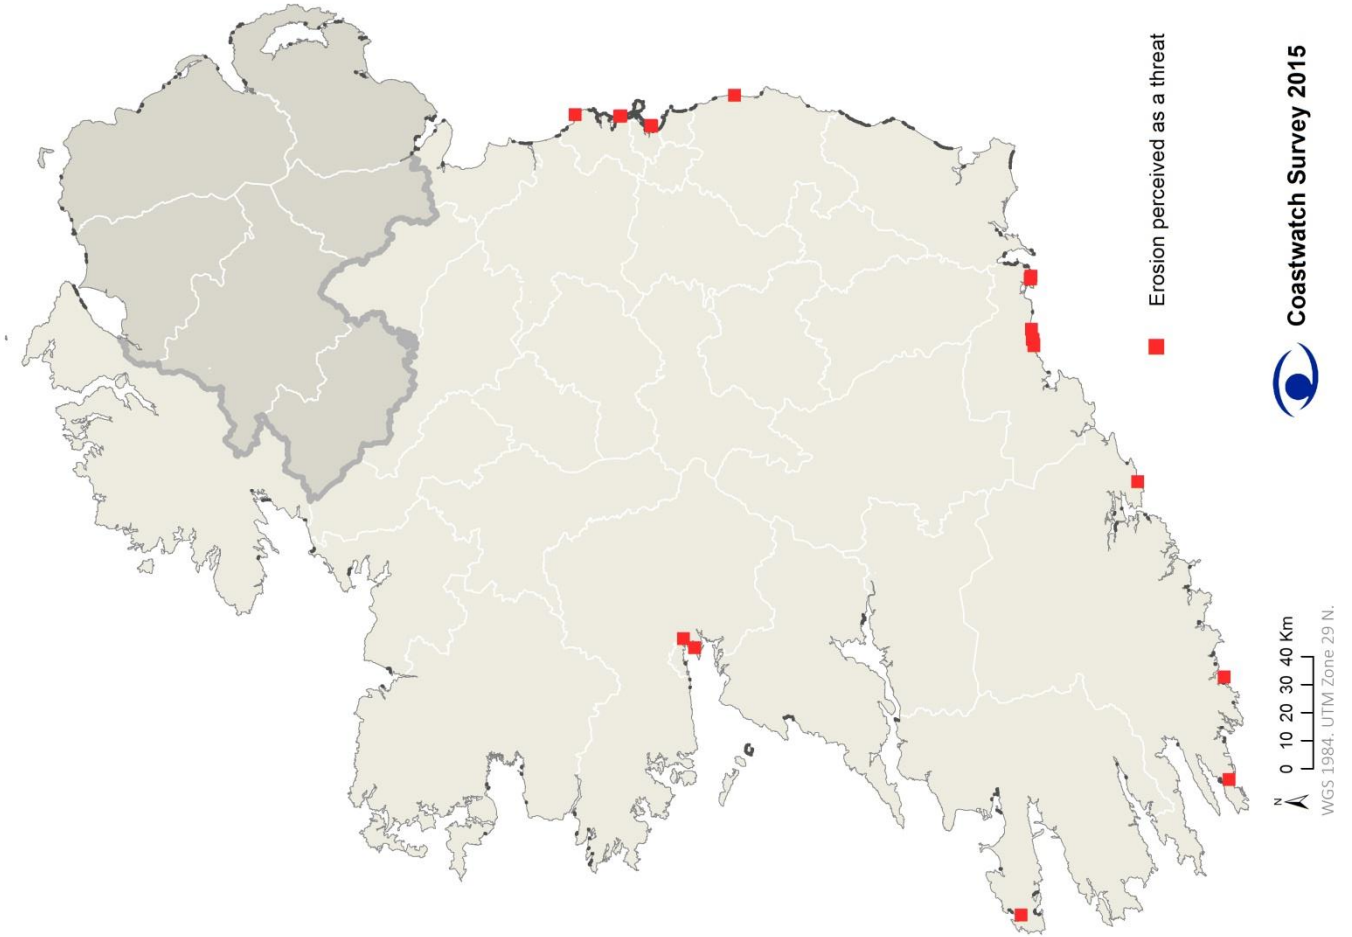
Threat of erosion

Erosion was perceived as a threat in 131 sites, of which 52 also were said to have some form of erosion control (walls, rock armour, banks...). Additionally there were 182 sites where a risk of erosion wasn't noted by our volunteers but that had some kind of erosion control (170 sites with hard erosion control).
