COASTWATCH AUTUMN 2016 SURVEY RESULTS

All Ireland - Part 1

Coast Character, Biodiversity and Water Quality

Karin Dubsky, Angel Duarte and Florence Lamouline

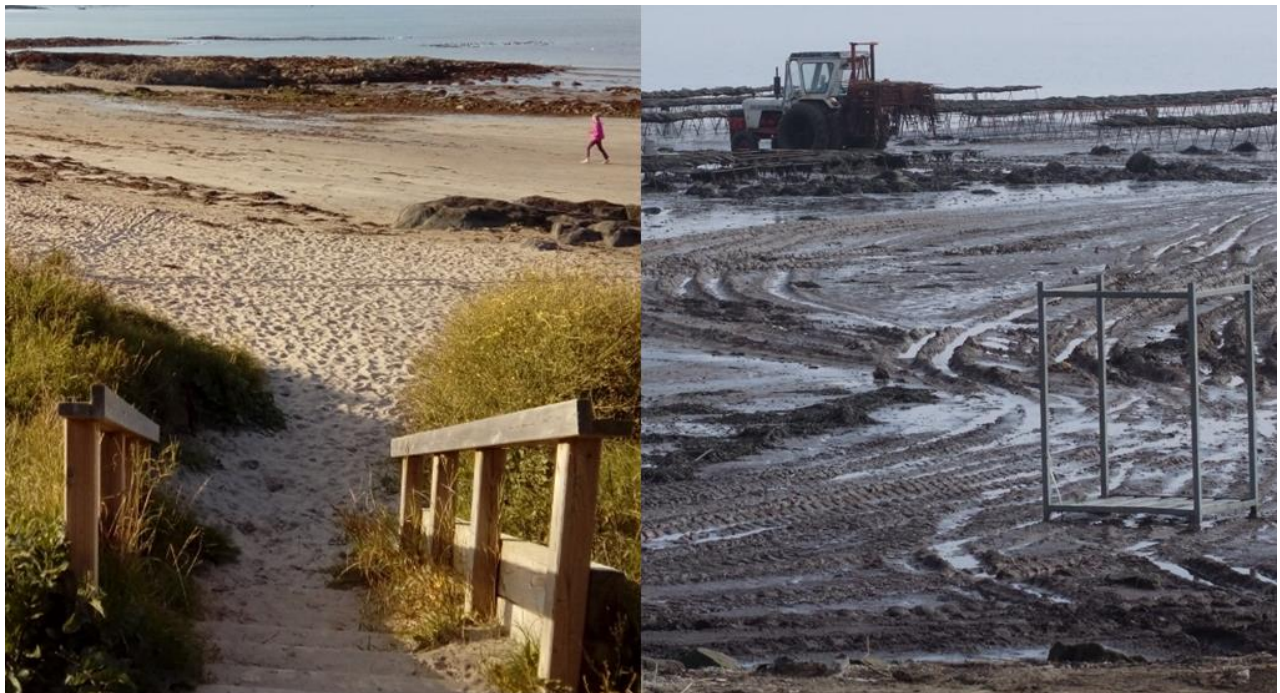
Traffic on the shore is another matter. Intertidal aquaculture operations - like Gigas oysters on trestles – normally depend on tractor access to plots, which can be highly damaging to sensitive mudflat habitats like sandmasons, or seagrass beds, but may have far less impact on a firm sand bank. In Lough Foyle surveyors noted deeper tractor marks and new shore access points due to rapid expansion of intertidal aquaculture spreading into the lough. None is licensed due to unsettled ownership matters.

Picture 2. 1 (i) Groomsport; Fingal. Photo by Geoff Jones. (ii) Intertidal damage from oyster farming.

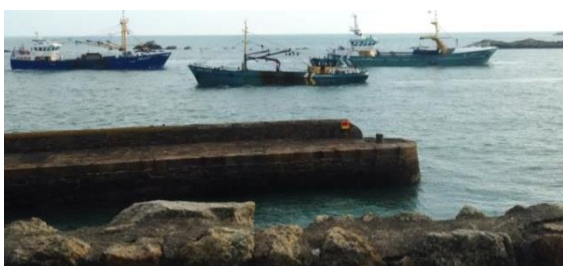
Picture 2. 2 Coliemore harbour. Old sea wall as hard erosion control. Photo Karen Downing

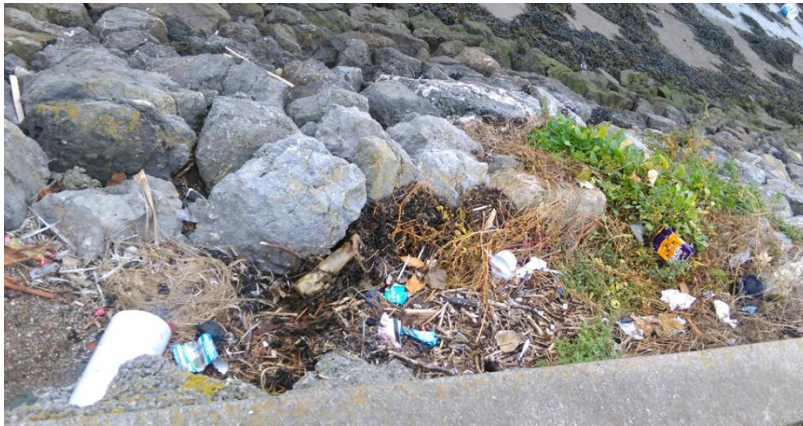
Picture 2. 4 Looking down a rough boulder sea wall, which also acts as marine litter tra.p Photo by Eiméar Manning.

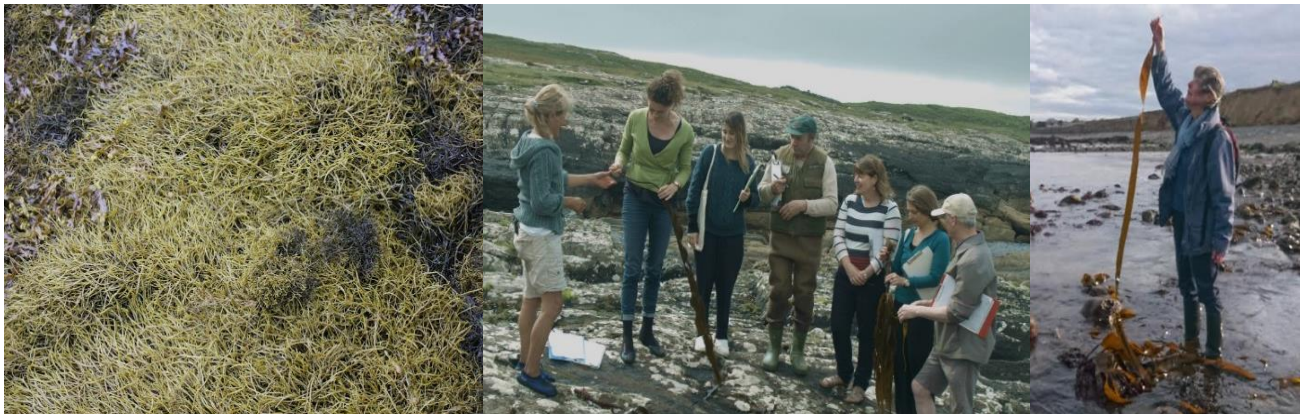
Picture 3. 4 (i) *Ascophyllum nodosum* ecad. *mackaii* (Photo Robert Wilkes) (ii) Coastwatchers testing the new seaweed module in Cork, (Photo Ecoeye) (iii) Regional Coordinator checking kelp length in Shanganagh

Over 2.1 m long egg wrack reported with photos, which puts them well above the 1.5 m typical length described in seashore books and many kelp measurements. Rare and protected floating rafts of egg wrack (*Ascophyllum nodosum* ecad. *mackaii* beds) in several sheltered Connemara bays and estuaries. While on notable but of concern the Invasive alien *Sargassum* seaweed was also found and in new sites - see IAS section 3.

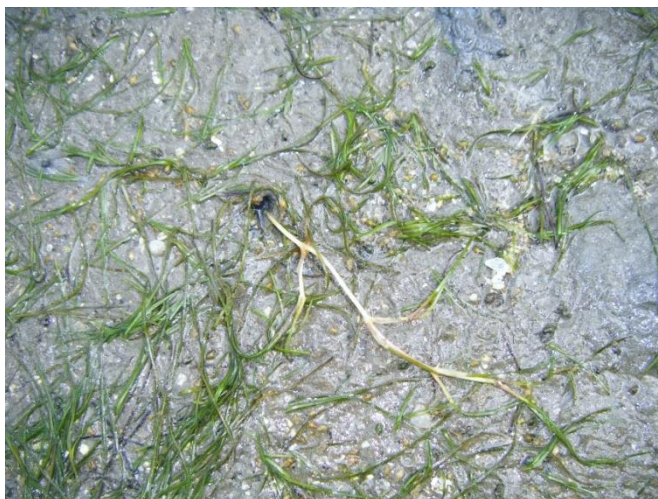
Picture 3. 5 A rather thin Seagrass *Zostera noltii* lawn on intertidal mudflats. Photo by Karin Dubsky

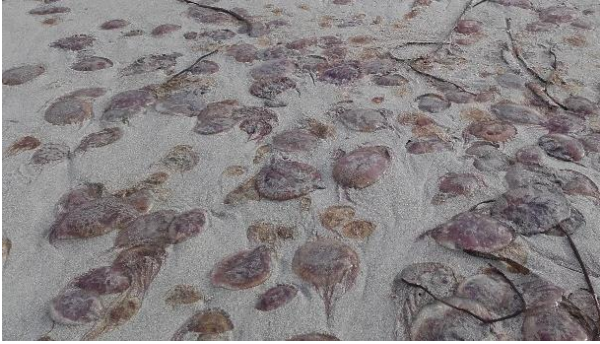
Picture 3. 7 Jellyfish carpeting the intertidal Galway - Photo Brian McSuibne

Some shores were just carpeted by stranded jellyfish and surveyors were uneasy walking over their bodies. Our survey data includes 11 sites with one or more Portuguese man of war and 79 with jellyfish. Calls from surveyors on several West Cork, Kerry and Galway shores noted the presence of Lion’s mane, Mauve stinger jellyfish and Portuguese-man-of -War as reason to postpone and then abandon surveys. Serious sting threat and school health and safety rules were the most common reasons. Coastwatch had produced a jellyfish poster with ‘stingometer’ to respond to calls for advice and to warn that some can cause nasty stings even when stranded and dead.

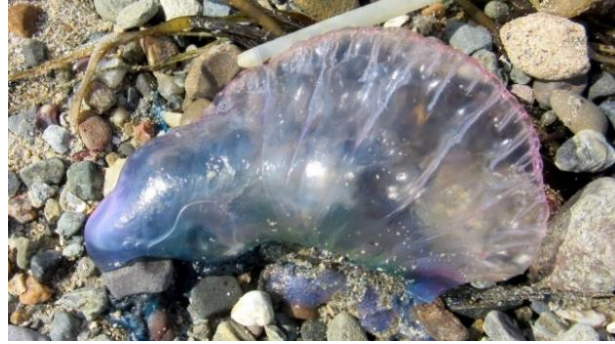
Picture 3. 8 Portuguese Man o' War, Kilmore shore – Photo Jim Hurley

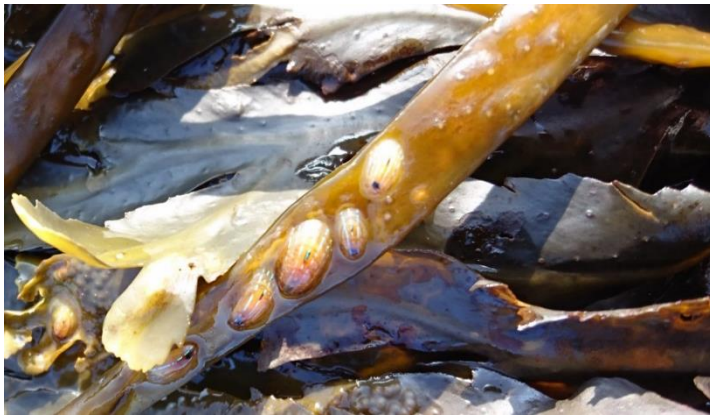
Picture 3. 10 Young Blue raised limpets on sea spaghetti.

After alerting surveyors to our interest in the Blue-rayed Limpet, *Patella pellucida* which lives mainly on kelp and as juvenile on sea spaghetti, a blue-rayed limpet site was reported from Dalkey, (Dun Laoghaire), augmenting a recent Coastwatcher record of one from nearby Sandycove kelp in rock pools. Prior to that we had not come across any blue rayed limpet record in the Dublin biosphere, but would love to know if

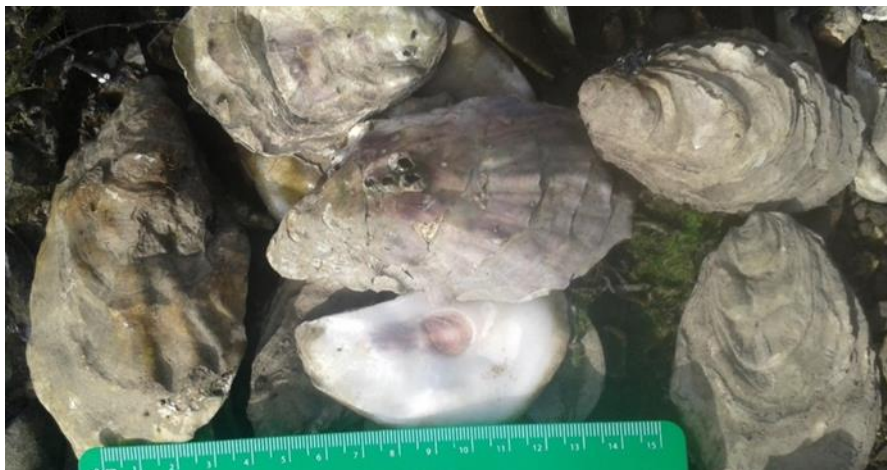
Picture 3. 11 Gigas Oyster shells. Photo by Darach Ó Murchú

In Carlingford Lough several surveyors found live native oysters of different size classes and in some areas the density was sufficient to be described officially as 'oyster bed'. It suggests that we may be seeing the recovery of old oyster beds on the Northern Irish side of the lough. Surveyors noted Gigas oyster cultivation in parts of the lough as a threat, with operations overlapping onto native oyster beds and as the cultivated **Gigas Oyster** is beginning to reproduce here and can take over intertidal areas when it becomes invasive. In 2016 Coastwatchers reported the first Gigas oysters cemented onto intertidal boulders on the

Rol shore at Carlingford village. The Lough has biodiversity hotspots - areas teeming with tunicates, peacock worms, sea pens and a range of molluscs and seagrass with flocks of shorebirds feasting on them. Surveyors also noted bottom mussel aquaculture activity, some of it involving removal of old intertidal mussel beds at 'The Narrows' with associated seafloor damage.

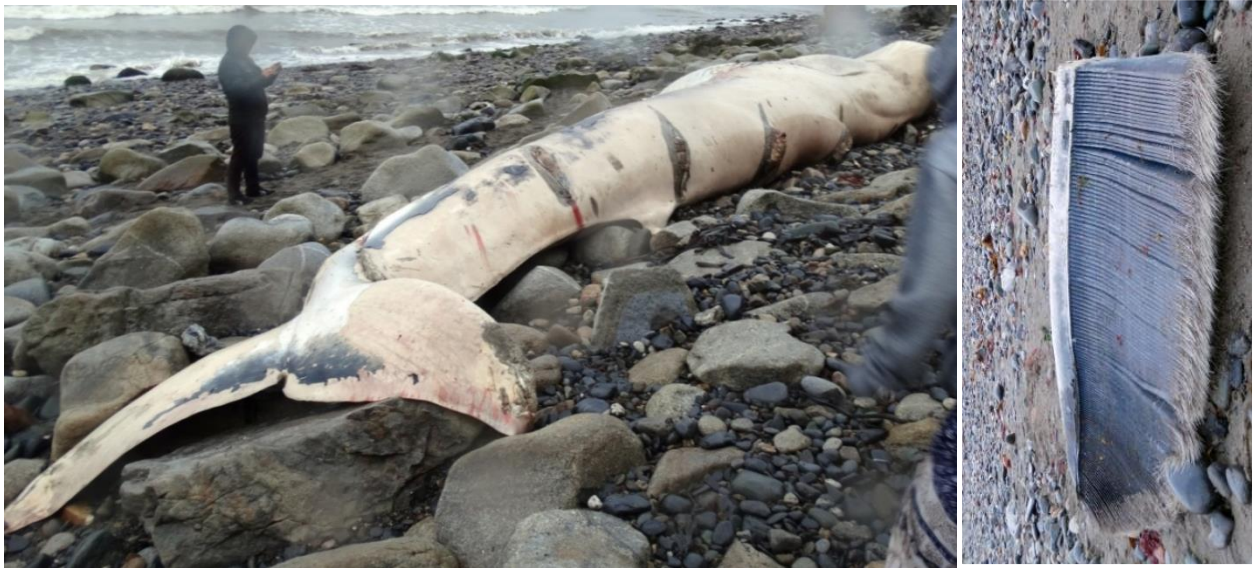
Picture 3. 13 Dead Fin Whale above and separate baleen Killiney and Shankhill Photos by Robert Nicholson

Seven live cetaceans were spotted over 3 survey sites and 5 dead ones in 5 sites. One of these was 'smell spotted' on Shankill beach, county Dublin. It was a large fin whale which had been swept up with many cuts and was later buried on the shore by Dun Laoghaire County Council. A giant brush like baleen - see picture 3.13 – was swept up a mile north and possibly from a second fin whale, as several people had reported spotting 2 whales around the Wicklow coast 2 days previously. (It was not counted though).

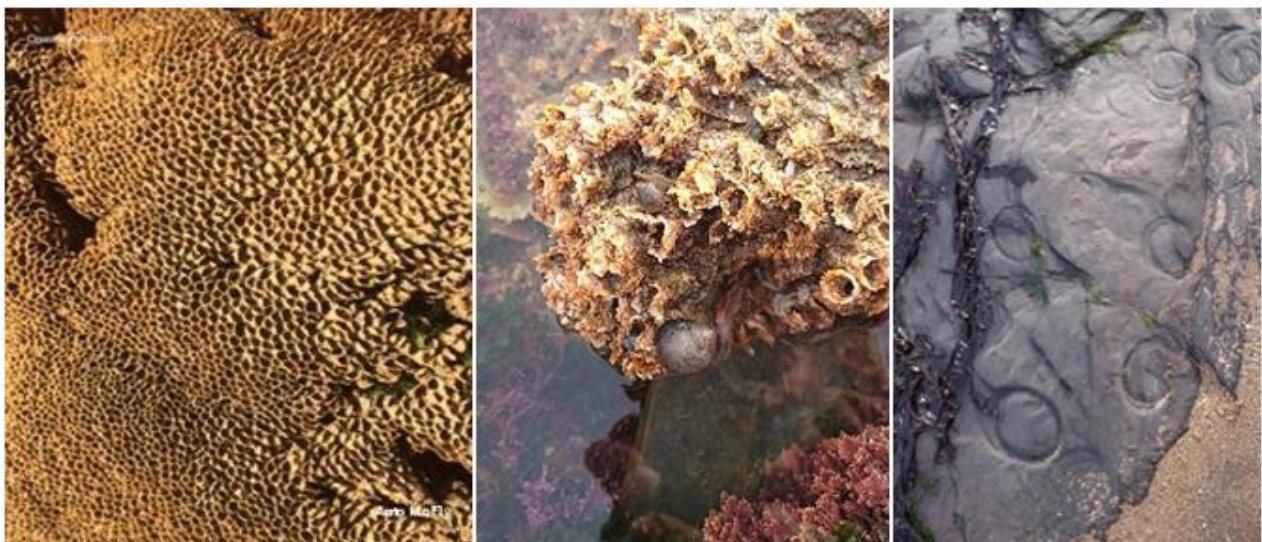
Picture 3. 16 (i) Dense healthy honeycomb reef 8_8_38_4_ Photo Anto McFly. (ii) Large disarray honeycomb worm holes emerging in spring 2017 after the green seaweed cover has washed away. (iii) Bare limestone left in some areas, where the circular limpet scars tell that there was once a time when limpets could grow old on this rock. Photos Karin Dubsy.

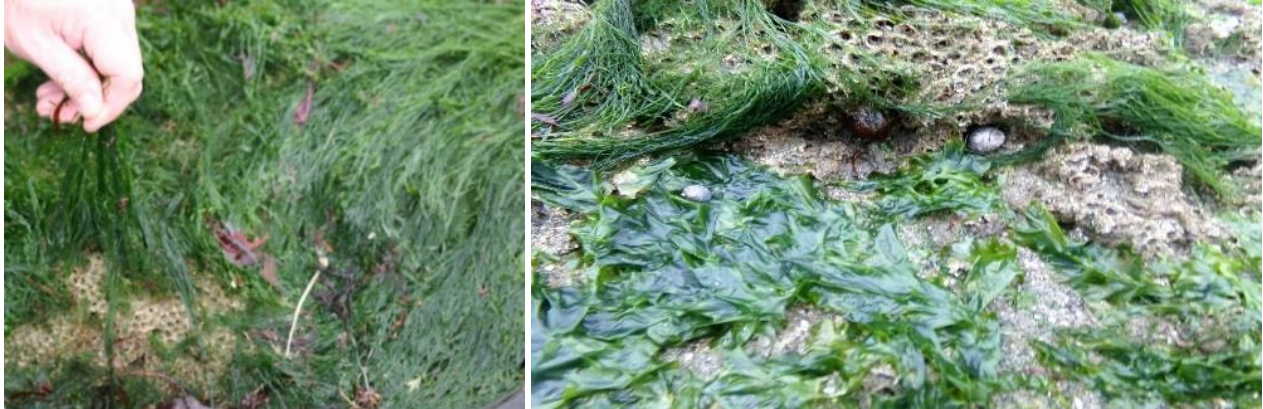
Figure 3. 11 Green algae on Honeycomb Reef. Photo by Paddy Houlihan

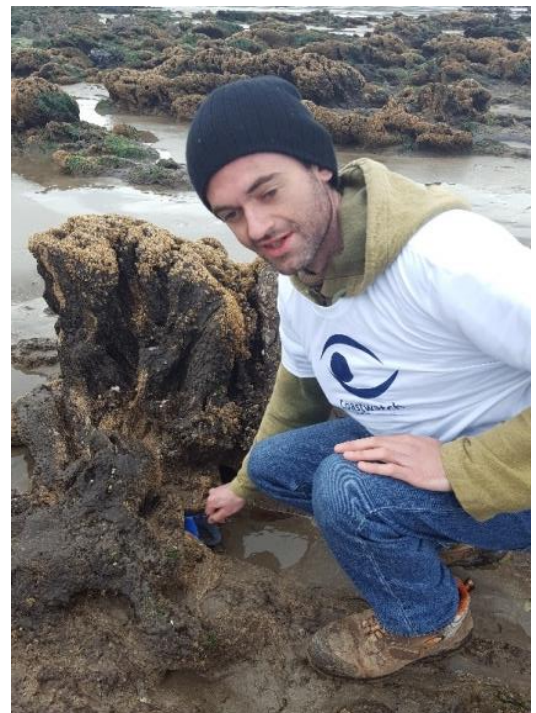
Picture 3. 17 Reef in break down phase. Alan Walshe, Waterford Regional Coordinator is touching a fishing glove incorporated by the worms during reef formation.

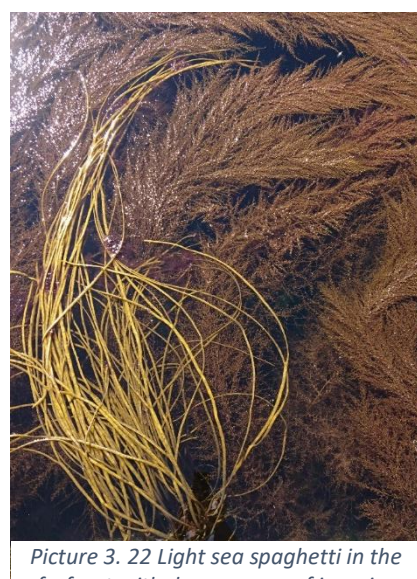
Picture 3. 22 Light sea spaghetti in the forefront with dense cover of invasive Japanese seaweed *Sargassum muticum*. Photo by Bantry Bay diver.

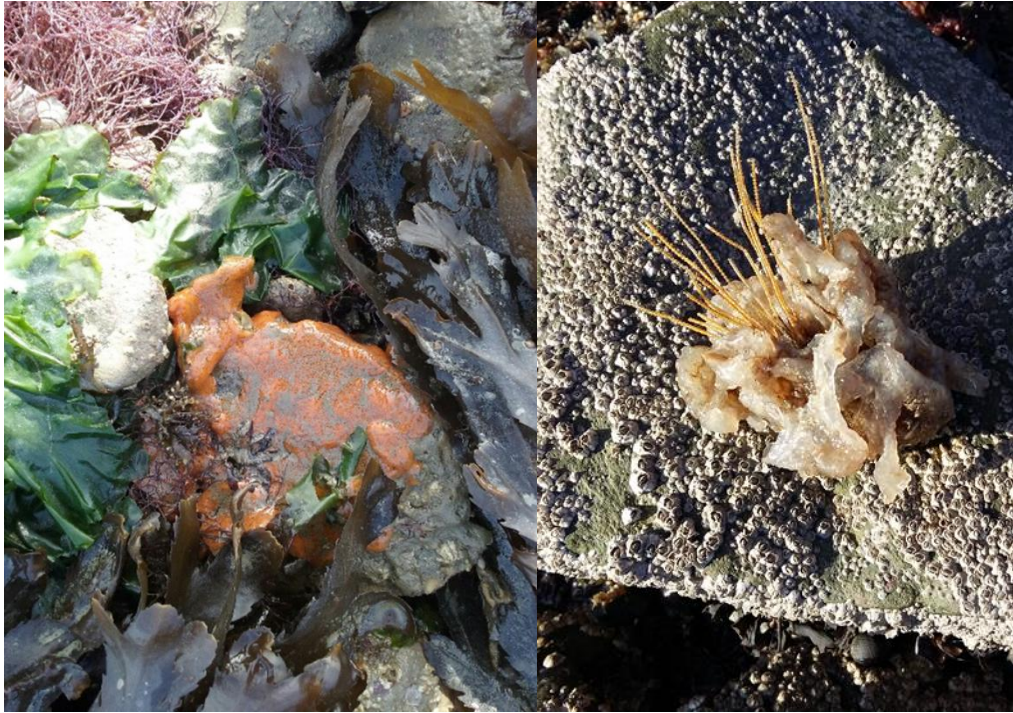
Picture 3. 23 (i) Marlogue Strand. Photo by PJ O Brian. (ii) Jelly around sea beard Photo Anne Laird.

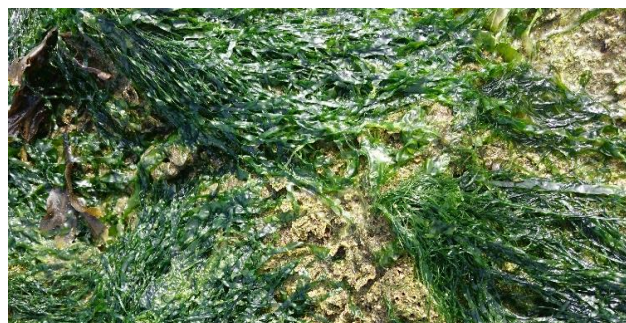
Picture 4. 1 Green algae on Sabellaria reef Photo Karin Dubsky

Surveyors in Waterford Harbour, on both Waterford and Wexford sites commented on unusual green algae blankets on the *Sabellaria* reefs. They observed that the reef was in poor silty condition or possibly abandoned, where so covered. In one area of Hook Head, the reef was totally blanketed in *Ulva* and *Sabellaria* only found underneath, as it was

carefully searched for where recorded previously. Surveyor Paddy Houlihan who has been checking his reef at Kilfarassy, Co Waterford regularly for at least 4 years noted, that he had never seen such extensive green algal cover. Drain and stream nitrate levels were checked and were raised to high (25 to 50 mg/l NO₃) in these areas.

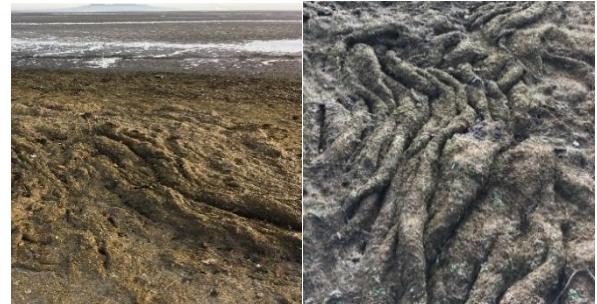
Picture 4. 2 (i) *Ectocarpus* carpet decaying S Dublin Bay and (ii) *Ectocarpus* bloom decaying on Booterstown shores. Photo Rory Keatinge

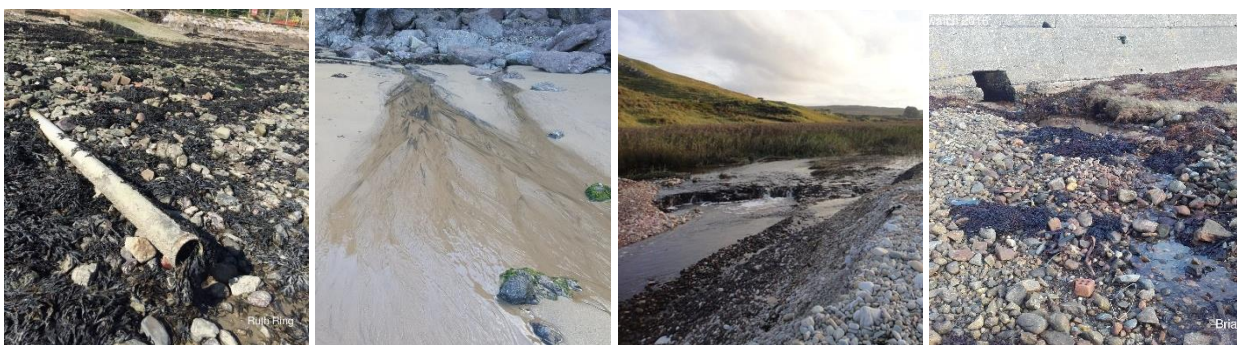
As shown in figure 4.3 over a third of the inflows (36%) were described as ‘pipes’ when entering the shore. From surveyor comments, this category includes some culverted streams though, as these enter the shore after passing under a road or lane. Stream bridges at the shore are vulnerable to erosion damage and may then be replaced simply by a concrete pipe. The next most frequent inflow category was water seeping in from land (22.6%) Seepage may enter above the shore such as a cliff face, or bubble up the splashzone or in the intertidal. Streams and rivers (which the surveyors had to cross rather than walk up along) made up 21.4% of the inflows and drains 20%.

Picture 4. 3 (1) Pipe; by Ruth Ring (2) Seepage; by Alan Deacon (3) Stream/river; by Polly Dollan (4) Drain; by Brian Mac Suibhne

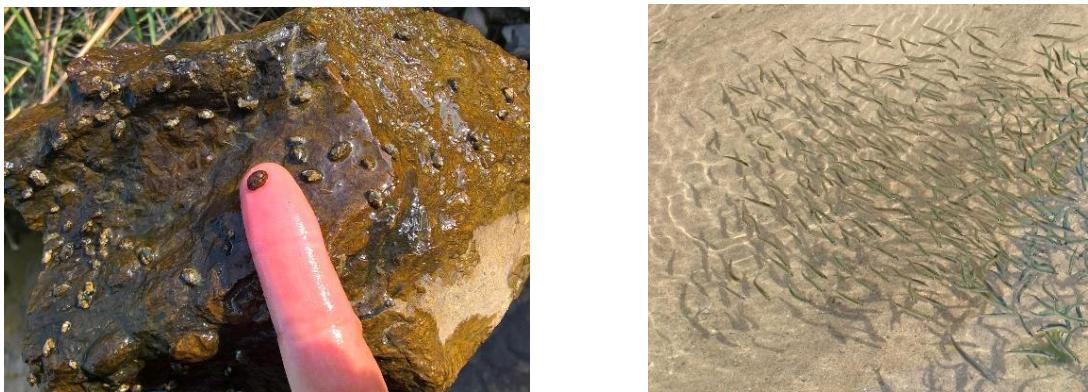
Live fish were reported from 11 streams, 2 drains and 3 pipes, which are assumed to be drains or streams which were culverted as they entered the shore. For 2 inflows the type was not specified.

Picture 4. 4 (i) Macro invertebrates on stone in drain; by Florence Lamouline. (ii) Shoal of sandeels in stream; by Alan Walshe.

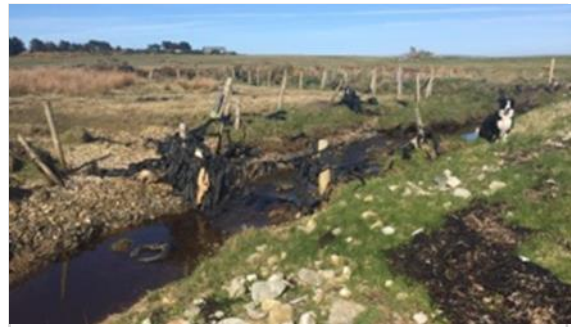
Picture 4. 5 Plastic sheeting in a 'manky' rural stream

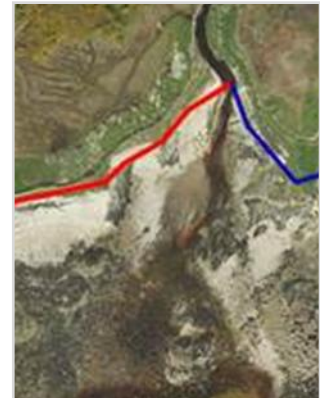
Not all discoloration/scum/froth is recorded as a bad sign by local surveyors. If stream discoloration is put down to natural conditions e.g. transparent water with brown humic acid discoloration, as seen in the satellite image (4.7) it may not be reported as 'bad sign'. The same goes for temporary discoloration after a heavy shower. Where surveyors don't know the area or they also see foam or peaty materials in the stream bed, the scum and discoloration are reported more readily. Given that 2016 was a survey with more dry weather than usual, few of the 8% discoloration recorded are likely to be weather related. For several streams, photos were submitted but the surveyor name is withheld. For example, picture 4.5 taken in a remote area below a farm. The surveyor noted that there was natural discoloration, but the stream bed was scummy and littered; both where seaweed had been lodged by the tides and inland above that.

Picture 4. 6 Humic acid rich discoloured river water visible from Google©

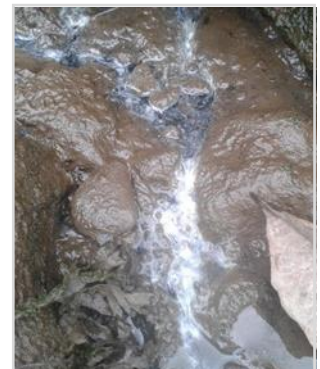
Picture 4. 7 Broken pipe discharge; Darach Ó Murchú

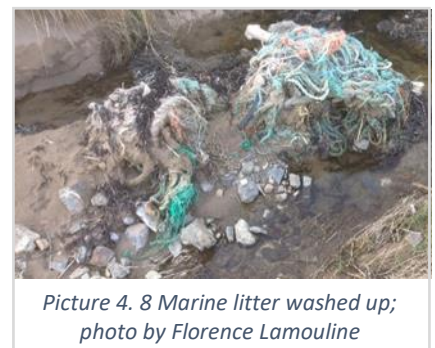
Picture 4. 8 Marine litter washed up; photo by Florence Lamouline

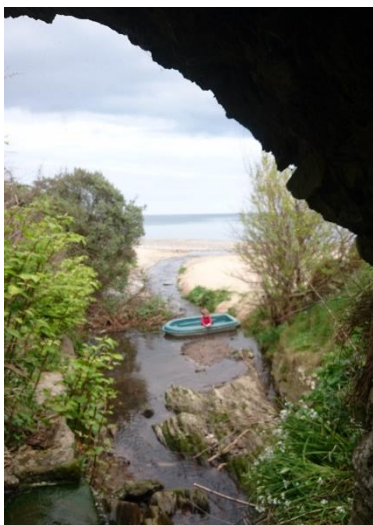
Picture 4. 9 (i) left: Invasive Japanese Knotweed on left bank of Ballymoney Stream. Co Wexford. Photo Paul Dubsky. (ii) below; Zebra mussels in lock gate Grand Canal basin Dublin. Photo Rory Keatinge

In autumn 2016 Zebra mussels were found and reported to IFI by Dave Tilly in the Dublin Grand Canal basin. The site was revisited as part of follow up work in March 2017 and zebra mussels were still present (see picture 4.9 ii). This area is right at the Dodder river mouth. Removal and a check to ascertain whether it has spread up that river was advocated by Coastwatch (See case study box on pages 40 and 41)

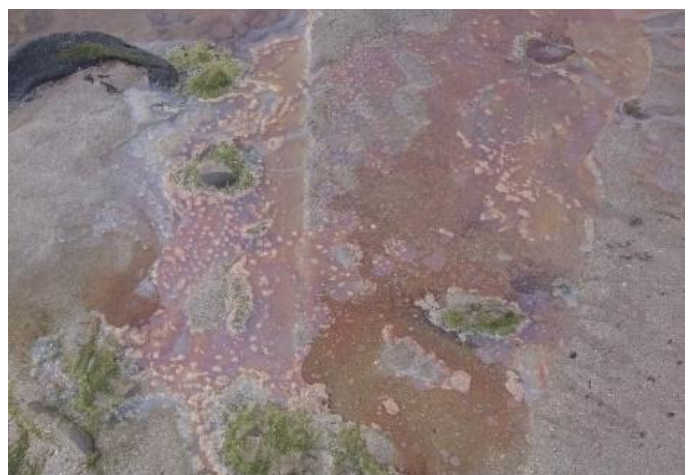
Picture 4. 10 Oil like shine, but cracking of surface shows this is not oil pollution but iron bacteria at work. Photo by Ellis Sheehy.

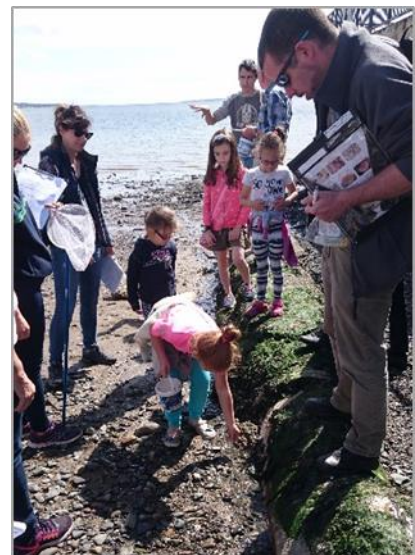
Picture 4. 11 Surveyors testing nitrates in seepage water from a broken drain in Carlingford Lough.

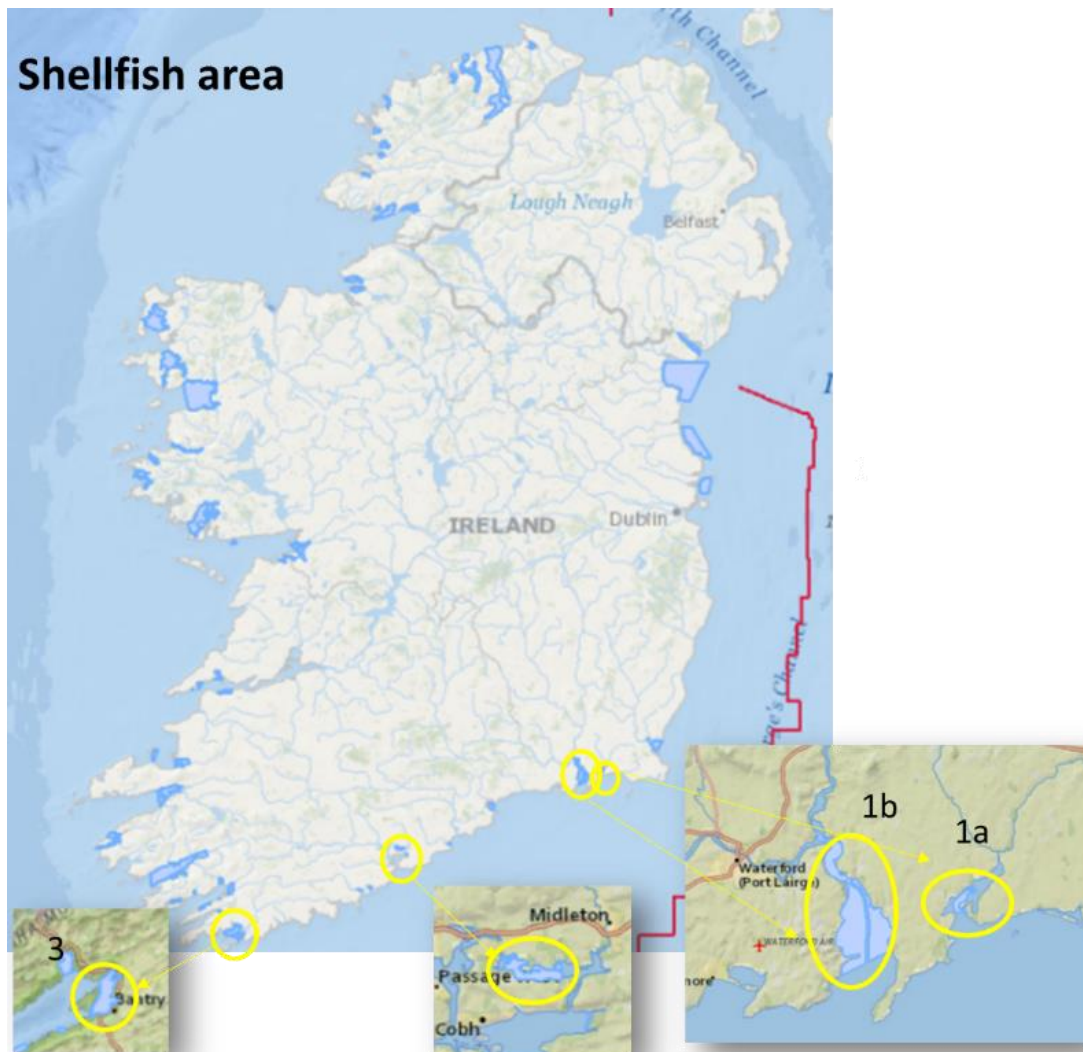
In the Republic of Ireland, 64 areas are currently designated as shellfish waters (S.I. No. 268 of 2006, S.I. No. 55 of 2009, S.I. 464 of 2009). In this section, we look at nitrate inflow test data in 4 of the designated shellfish areas as mapped (Figure 4.17 below). The four areas are Bannow Bay, Waterford Harbour, Cork Harbour and Roaringwater Bay.

Figure 4. 17 Shellfish Areas Republic of Ireland <http://atlas.marine.ie/> and highlighted the 4 areas where Coastwatchers tested a number of inflows entering the shellfish water. In all some raised nitrate levels were reported, with levels breaching the nitrates directive 50 mg/l limit in Bannow Bay, Waterford Harbour and Cork Harbour.

In all 4 at least one inflow tested had nitrate levels 25mg/l NO₃ or higher. Two of these - Bannow Bay and Cork North Channel - stood out as having several inflows with high nitrate levels. They are also among the 10 shellfish waters which did not meet the E coli guide value on several occasions between 2009 and 2015. Nutrient levels were also high in some of officially monitored inflows into these waters. For further information on shellfish waters see the Irish Marine Atlas <http://atlas.marine.ie/>
