# Coastwatch Autumn 2013 Survey Results

ADVANCED DRAFT

**ALL IRELAND**

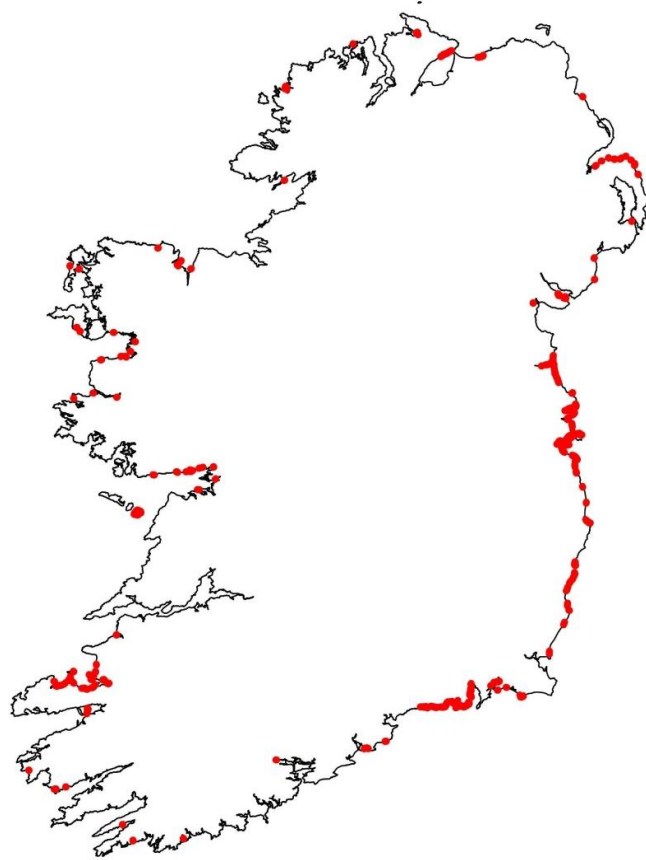
Figure 2. Areas surveyed in the Coastwatch autumn 2013 all Ireland survey

Northern Ireland which only started the new GIS method survey on a pilot basis delivered 26 survey sites and the Republic of Ireland carried out 521 surveys. The graphs below show the amount of coast covered in each county. Waterford had the most surveys with 115 surveys returned, followed by Kerry with 81 sites. The short Meath coast had the best representation with its entire coastline covered by surveyors.

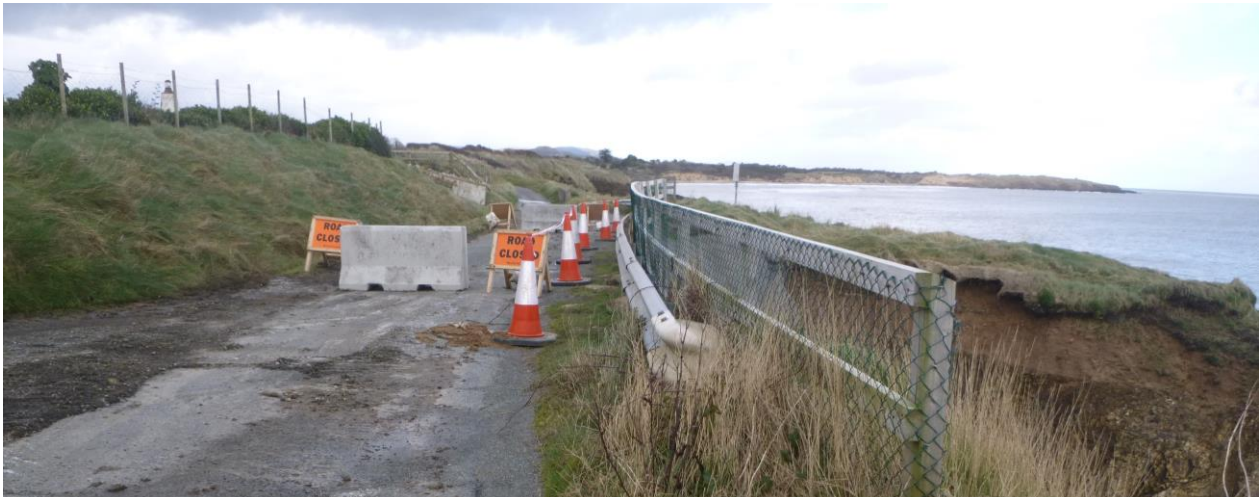
Closed sea road in N County Wexford as erosion threatens. Picture by Paul Dubsky.

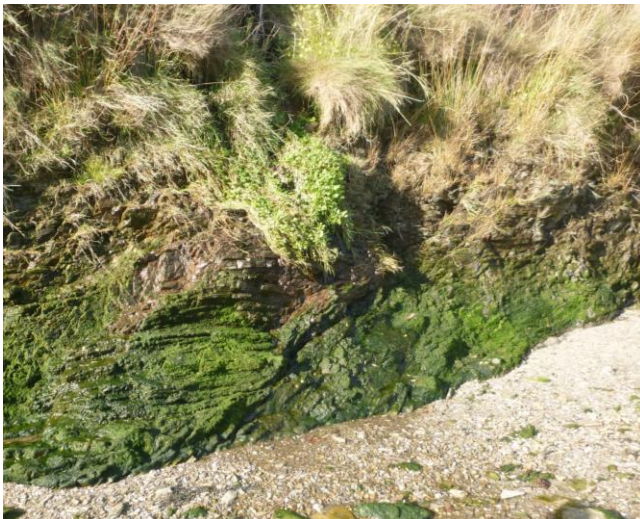
Bannow Bay. Picture by surveyor.

For a given amount of rain falling on an area, the portion retained or running off as inflows into coastal waters, depends on a number of factors including the geology and land use of the hinterland. In picture opposite water is seeping out from the eroding rock covered in green algae. Here (inner Bannow Bay) we found high nitrate levels but in small volumes.

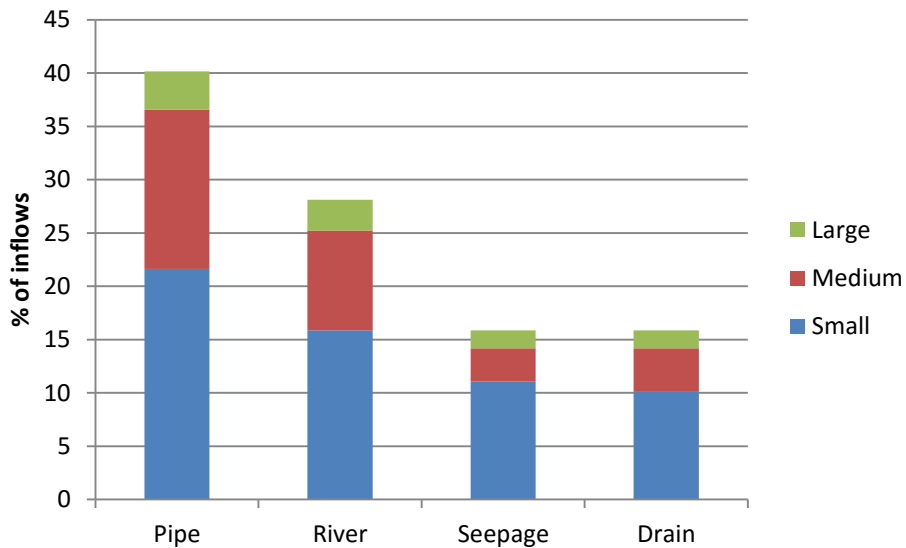
Figure 8. Type and size of inflows. (N=416 inflows; Source: Question B2. Totals: Pipes 167; Seepage 66; Drains 66; Rivers 117)

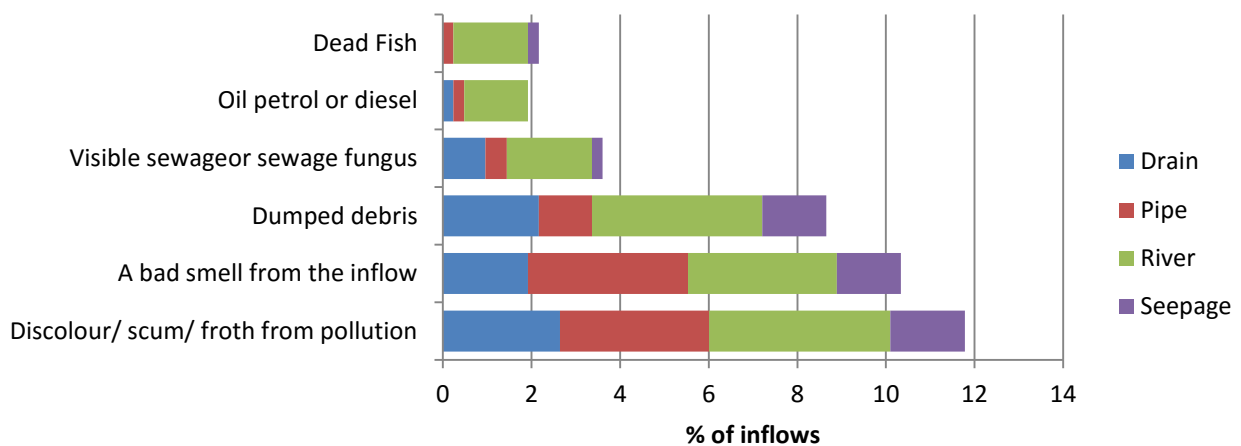
The worst inflows showed signs of 6 different types of pollution. There were 5 such cases (with 3 of them in Co Down) and 3 cases with 4 poor quality indicators. There were 8 cases of oil pollution and 15 cases of visible sewage or sewage fungus, most of them occurring in rivers.

Figure 9. Percentage of rivers, drains, piped inflows and seepage reported with water quality issues when surveyed. (416 inflows in 498 survey units)

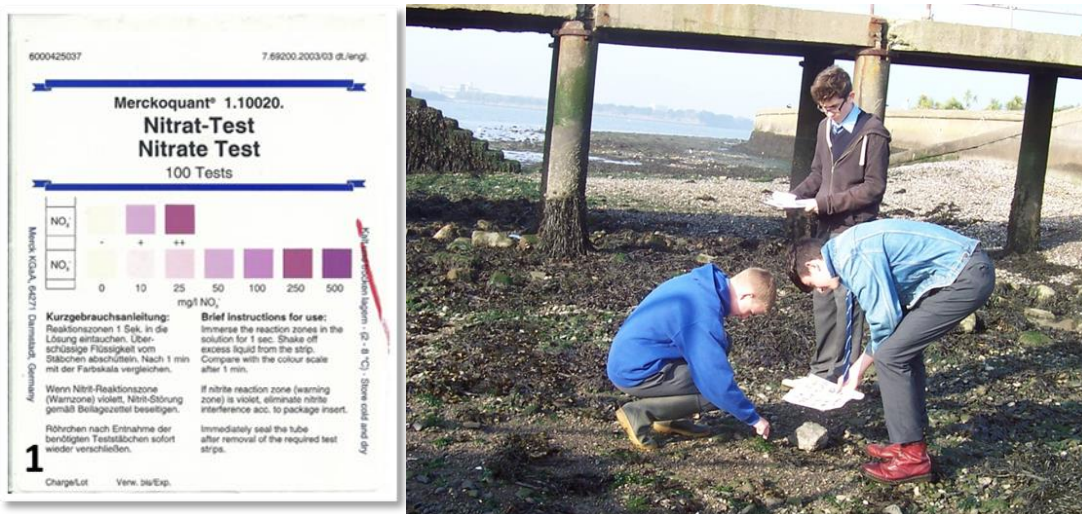
Figure 10. Colour chart for nitrate/nitrite testing. Students from Ardscoil Ris, Dublin surveying at Clontarf. Photo Michael Walsh.

Apart from visual and smell information surveyors who sent a request were also furnished with individually wrapped Merck Nitrate/nitrite test kits, colour charts and instructions to test their inflow once during the survey. Results for 81 of the 416 inflows encountered are presented in the pie chart figure 11 below.

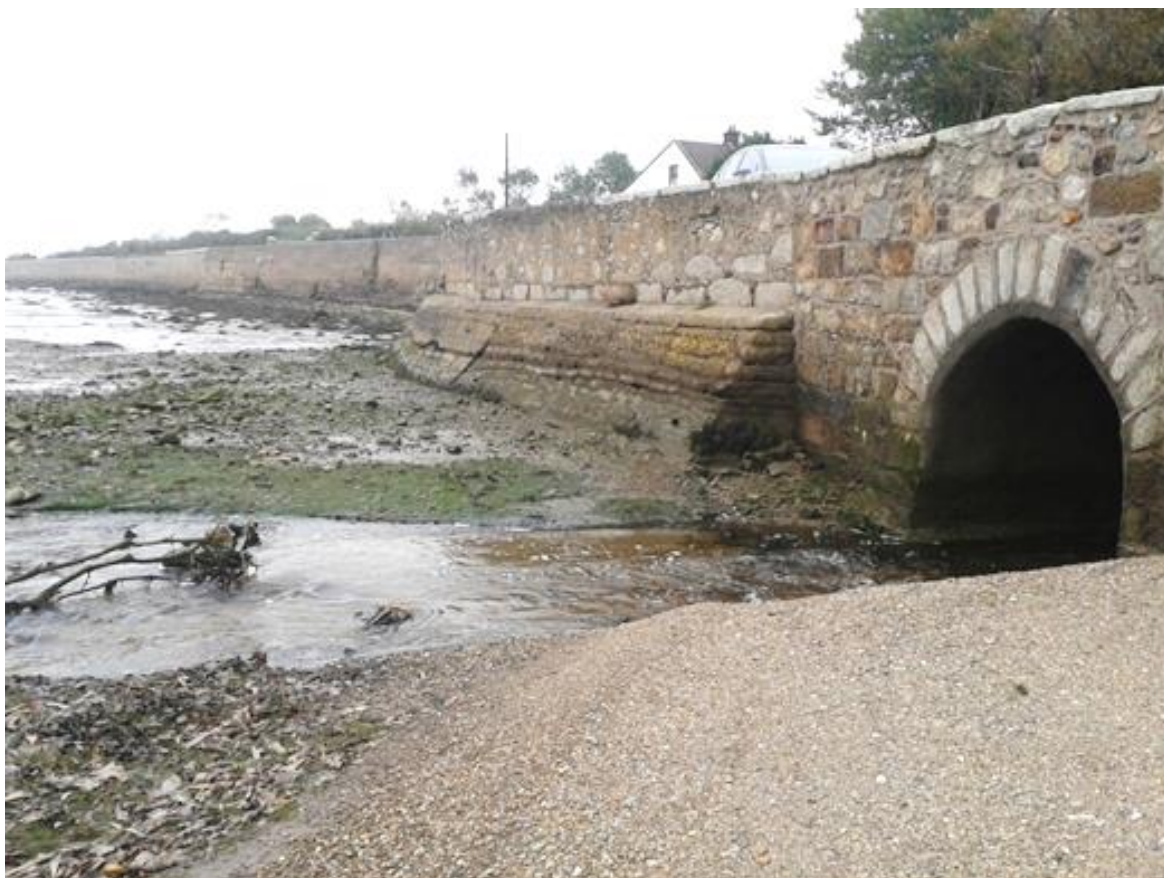
Photograph of stream inflow. Picture by surveyor.

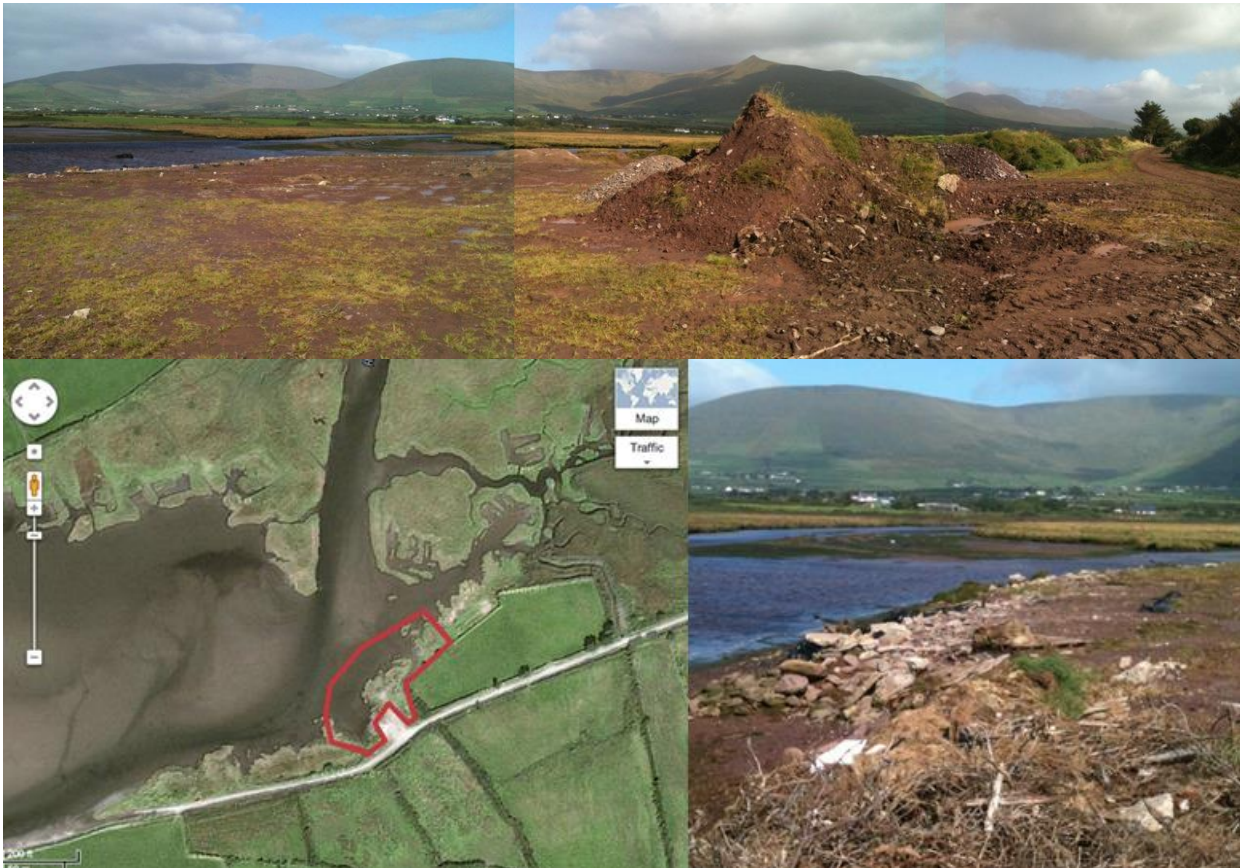
Figure 12. Map and photos of Trabeg Co Kerry unauthorised protected saltmarsh infill Oct 2013 photo surveyor

Although threatened by overgrazing, from land reclamation and infilling for agricultural use, the latest available survey of saltmarshes by the NWPS (2009) concluded that this habitat is in overall good condition. Coastwatchers recorded more frequent flooding in several sites, more raised banks to overcome the flooding and some infill turning marsh into raised made ground. That included one now being addressed by Kerry County Council at Trabeg estuary. The surveyor noted: 'this whole area was salt marsh, but is now freshly filled in. Additional piles of sand and mud have been brought in and a large pile of railway sleepers.'

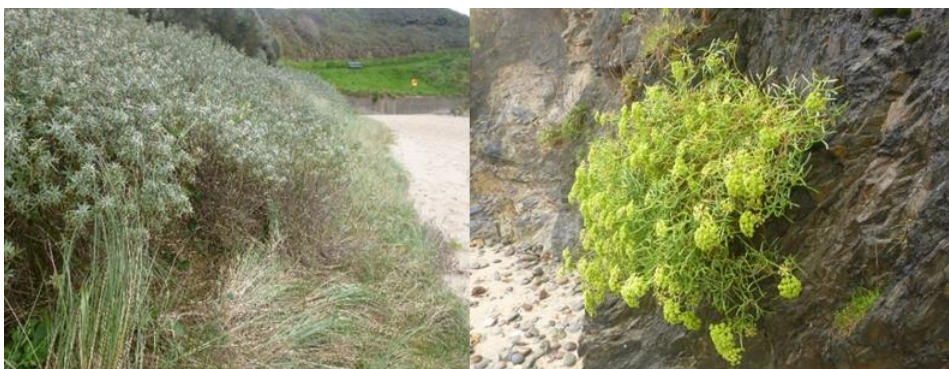
(Left) Sea buckthorn taking over marram grass foredune and (right) Rock Samphire. Pictures by Karin Dubsky.

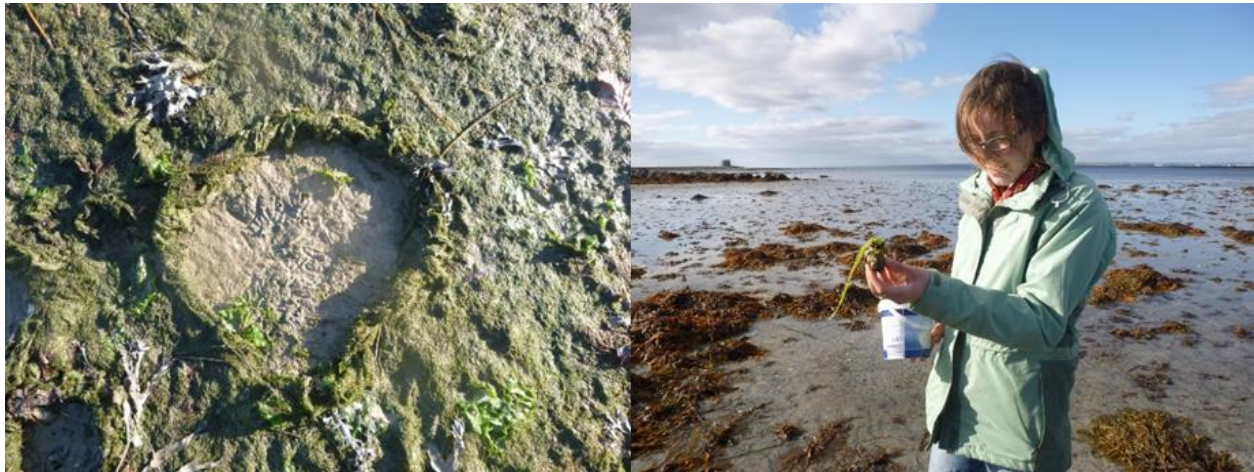
Green seaweed patches were found in over half of the sites. They are usually associated with fresh water inflows and muddy shores. Thick carpets of green seaweeds associated with. In 16% of survey units tend to be signs of nutrient enrichment e.g. from sewage or agriculture. The long good weather might have encouraged carpets to form and remain in situ in October while in a stormy year the carpets are moved by the sea. In Bannow Bay oyster catchers were observed moving around on the seaweed carpet when foraging, leaving characteristic saddle shaped patches where they were feeding – see photo below.

Photos of Oyster catcher clearance in *Ulva* seaweed carpet Bannow Bay and regional coordinator Kat Keaghan in Galway Bay finding dislodged *Zostera marina* strands on a muddy sand, dotted with boulders where brown seaweeds flourish.

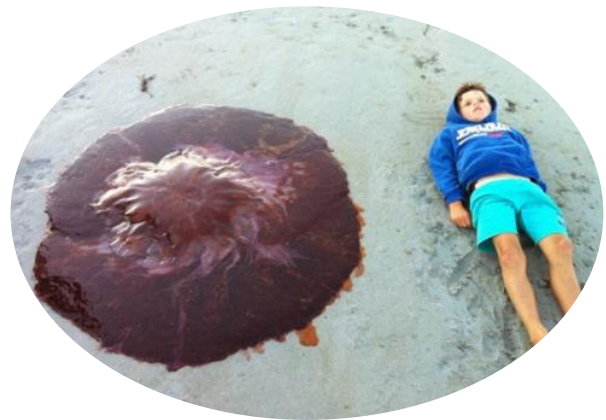
Figure 15. Jellyfish reports mapped for the 2013 survey.

**Jellyfish** (both alive and dead) were found in 20% of the survey units - see figure 15 below. This is a marked increase from last year, where they were reported from only 6% of survey sites.

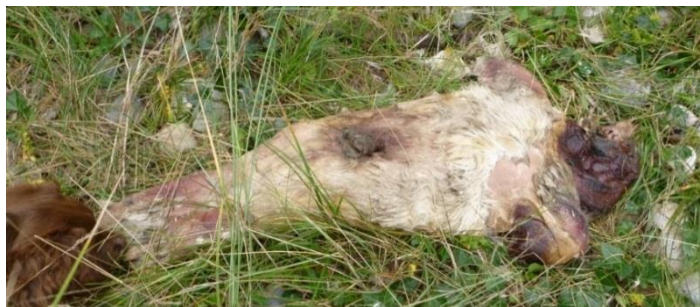
The number of dead seals and reports of seal culls in several areas this summer and autumn is of concern and is being followed up by the NPWS and the Irish Seal Sanctuary.

Dead seal washed up on Seafield beach, North Co. Wexford. Picture by surveyor.

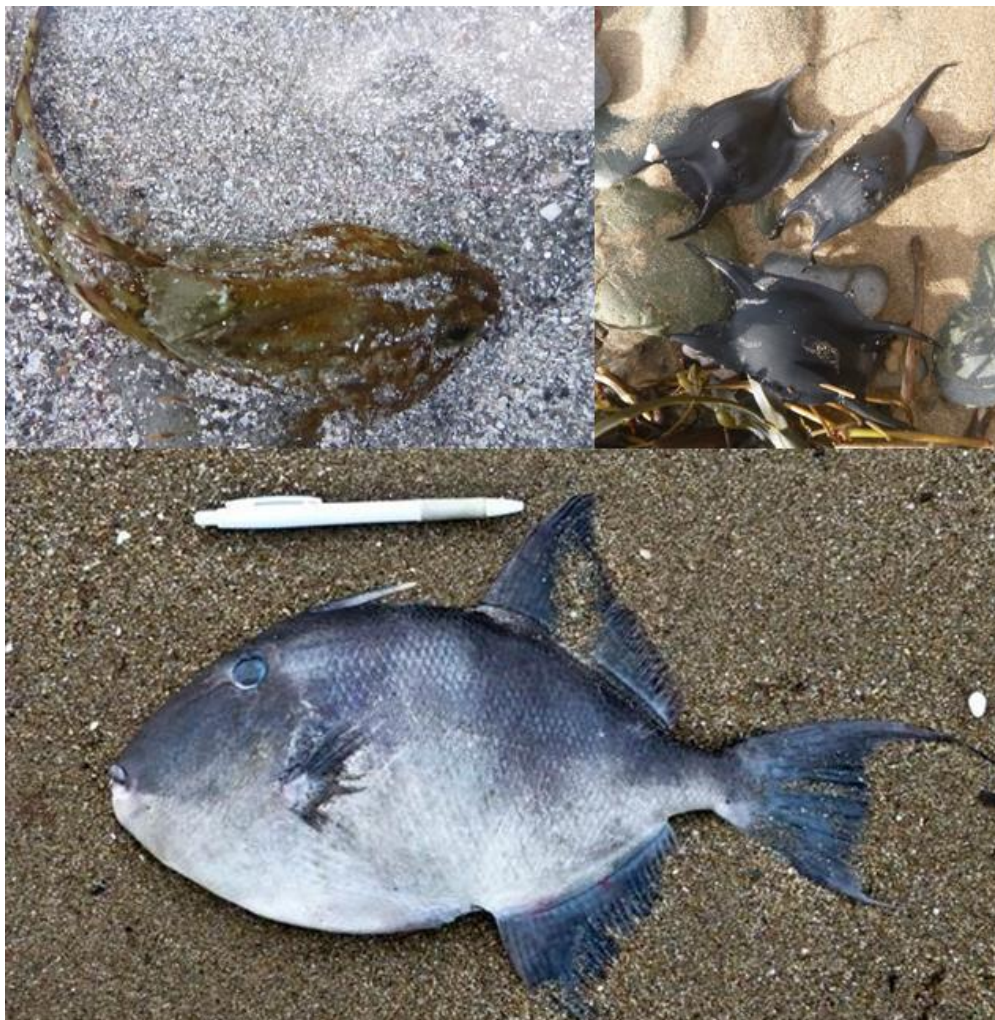
The most unusual fish find was reported from Lough Foyle where Edward Farren and William Guildea in Moville found a large warm water triggerfish. This was the latest and furthest north sighting on record. Fish egg capsules or mermaids purses of ray, skate and dogfish give an indication of presence of these species in breeding condition in the wider area.

Photos (top) of typical intertidal fish and egg case assortment reported from many sites and (bottom) a rare Trigger Fish from Moville, Lough Foyle. Pictures by William Guildea.

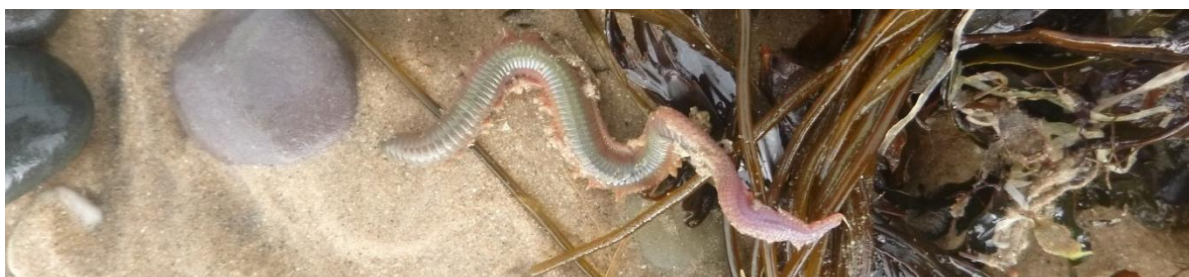
The Ragworm (*Nereis*) was found most commonly in our survey, which is not surprising as it is widely distributed around all coasts of Britain and Ireland. Although not protected by law, ragworms are incredibly important for oxidising the sediment. They are also an important food for many species of bird found on our shores.

Ragworm found in Dublin Bay. Picture by surveyor.

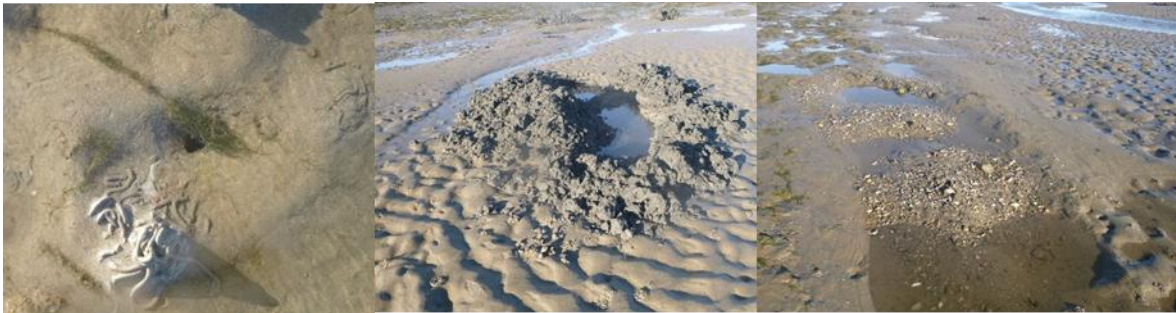
Lugworm intake hole and cast; fresh and week old damage caused by bait digging without back fill. Pictures by Karin Dubsky.

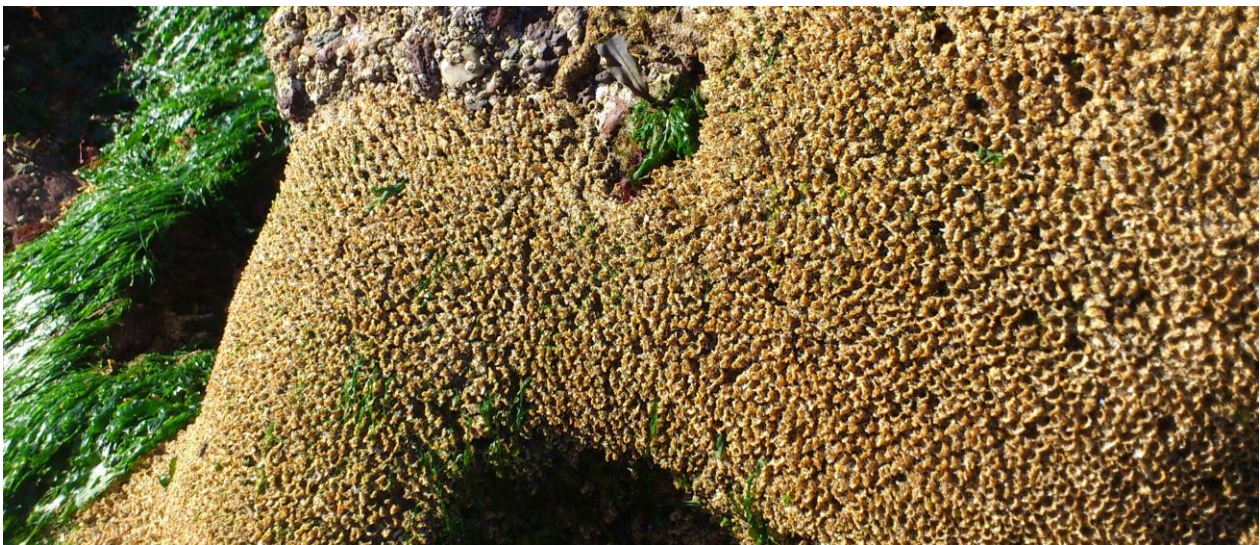
Thin encrusting honeycomb worm reef at Rathmoylan Co Waterford. Photo Andrew Cox Newtown School.

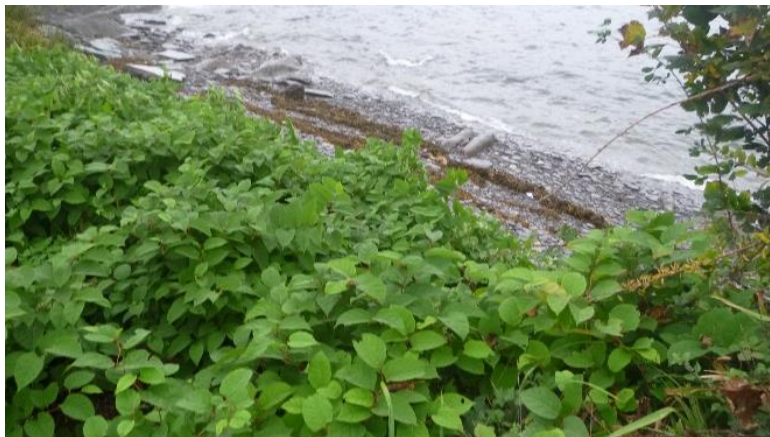
Japanese knotweed flourishing in Schull, Co. Cork around the harbour and other sites, but often not identified until it flowers. Picture by Karin Dubsky.

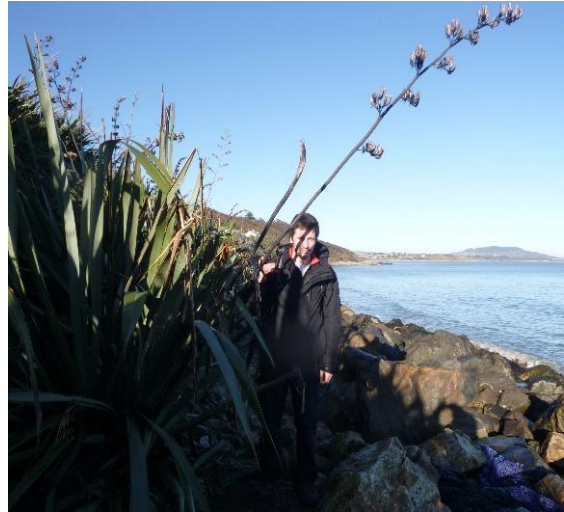
New Zealand flax Ardamine. Picture by Ronan Carvil.

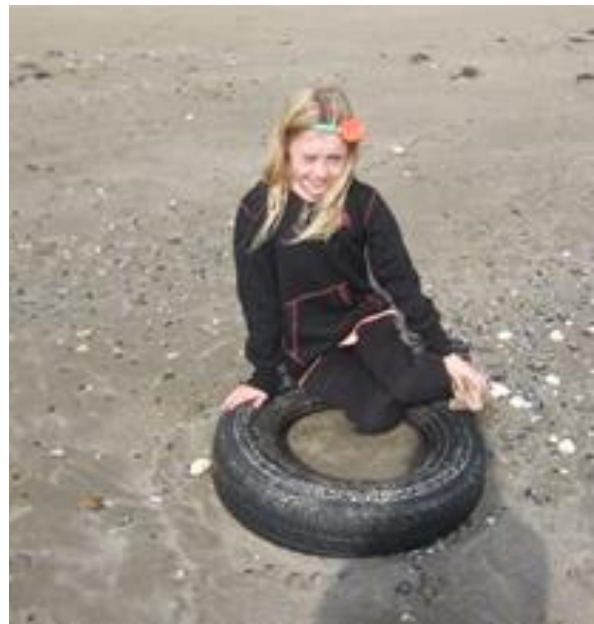
Old tyres are a priority waste stream and not supposed to go into landfill sites. The shredded rubber compounds have various uses and the whole tyres too are often used as buffer between boats, on quay walls. In recent years they have also be seen set in long lines on intertidal shores to attract peeler crabs. These catch traps which have no permits belong to those who set them and regularly check them for the crabs used as fishing bait. But ownership vanishes when the tyre sinks too low into silt to be useful.

Tyres are often warmer than surrounding shores. So nice to sit on as surveyor, or in as peeler crab. Photo Nuala Freeman.

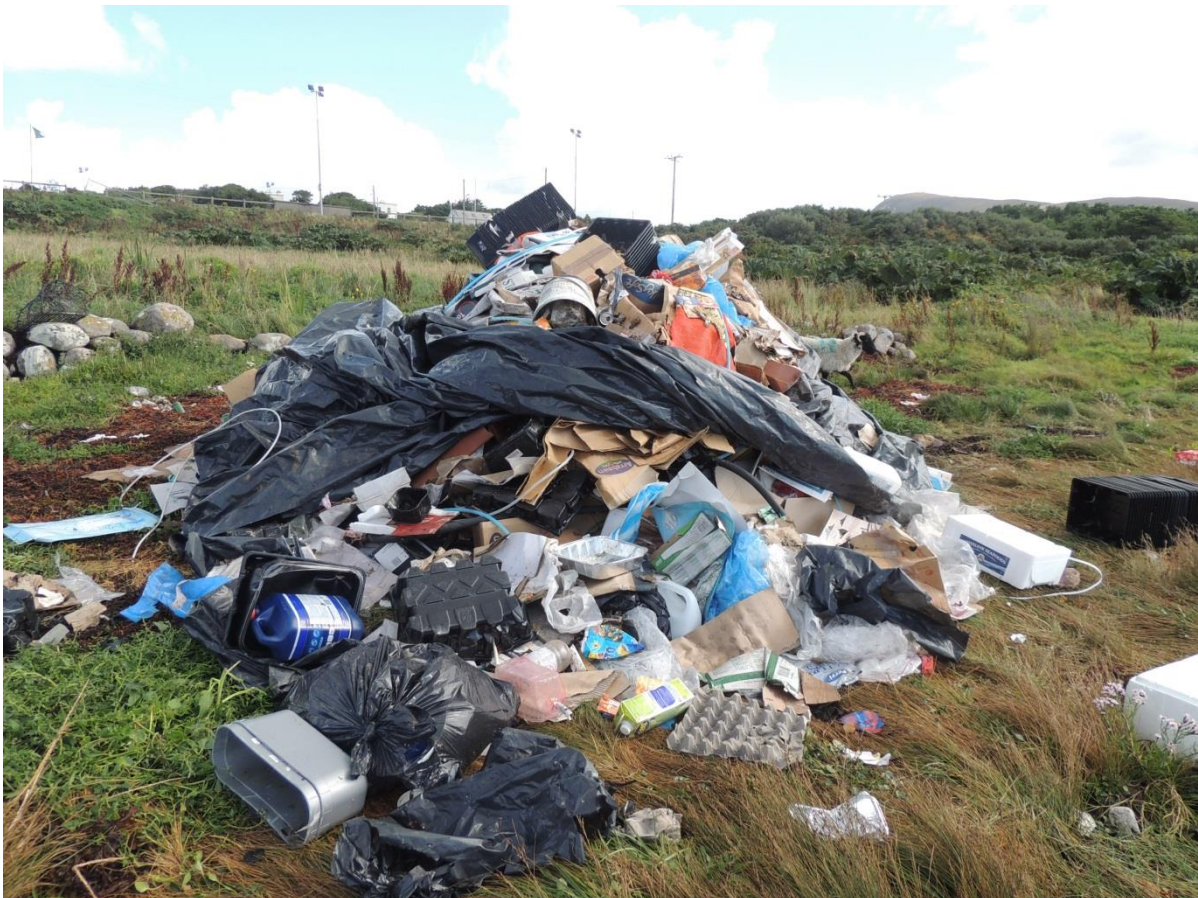
Dumping on beach edge at Achill Island, Co. Mayo. A surveyor reported it and perpetrators cleaned up. Photo Nuala Freeman.

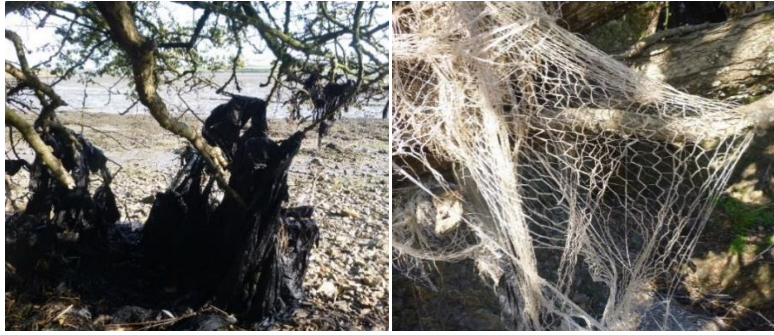
Silage bale wrapping and hay bale type netting caught in overhanging trees on the shore. Picture by surveyor.

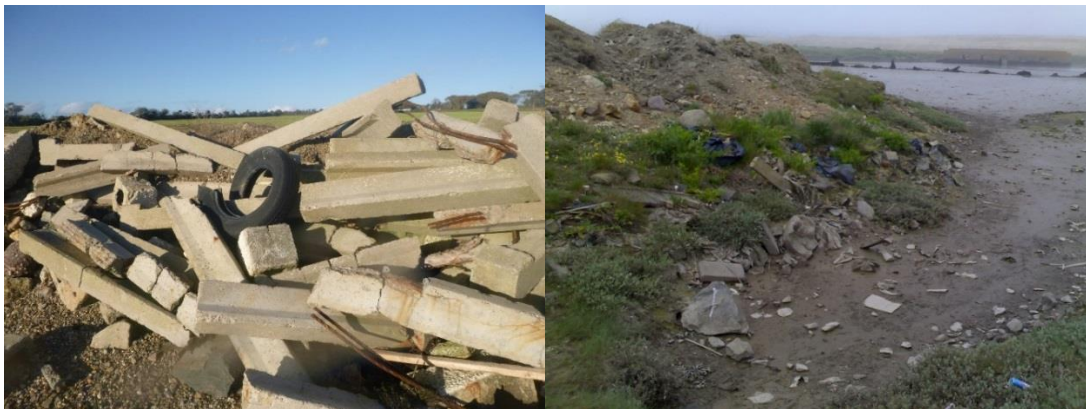
The use of demolition materials as do it yourself erosion control was remarked upon by several surveyors in different counties and photos highlight that considerable volumes can be involved when a whole field front is decorated by such materials.

End of tillage field erosion control using demolition waste in Bannow Bay Co Wexford. Photo Alice Michieli and mixed C&D waste and earth and stones at the edge of Tramore backmarsh, Co Waterford.

The issue is complex. Landowners want to halt erosion and raise embankments around low coastal land to keep floodwaters out. While understandable, there are potential and often predictable consequences for others. Floodplains that can no longer flood may lead to flooding elsewhere. Apart from the urgent need to consider this bigger picture there is the issue of material used in erosion control - as in the Bannow Bay picture above, or when strengthening an old dyke. Storms may pull the defence apart and strew that waste over a larger area, or grind it down into smaller material and micro litter. As demolition waste can contain hazardous materials like asbestos, waste law is clear: You cannot dump this without a waste permit. A foreshore license is needed for other erosion control and in case of locations in or near Natura 2000 sites, an extra appropriate assessment is needed. We have many shores which would naturally melt into the soft low lying hinterland but has been drastically altered with visual effects like

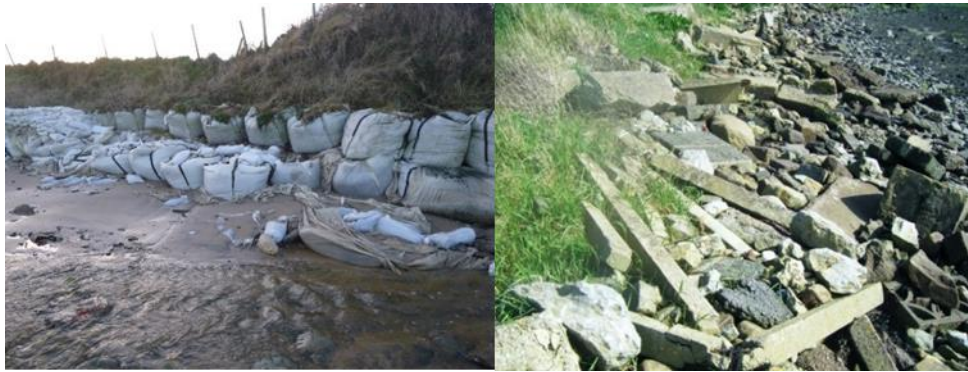
sore fingers as captured on the right picture below. On cliff shores these 'sore fingers' may dominate the view for shore visitors, but may not impede the sea side villa owner's view -- as on the left picture below.

White erosion control sand and mortar sacks which the sea is taking apart at Kilpatrick dunes, Co Wexford (left) and Construction waste dumped onto the edge of the Dungarvan harbour Natura 2000 site is in the same position as in 2012 (right). Picture by surveyor.

Some areas mentioned in the 2012 survey as requiring attention were resurveyed. The Dungarvan Co Waterford shore SPA edge is still a long line of C&D waste, similar to Ringsend Dublin city Nature Park (previous dump) high water mark and splashzone, which one 2013 surveyor described as 'a disgrace'. The water's edge from Tramore, Co Waterford car park to old dump as well as the so called 'Driver's dyke' also need a nature friendly make over.

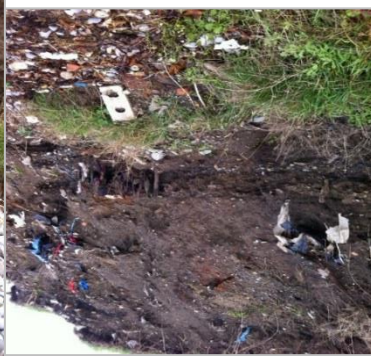
referred to as 'landfill sites' may now be closed, but seaward edges are in urgent need of monitoring and attention. The eroding Bray dump, surveyed in 2012 and flagged as of concern, was photographed again this year by another surveyor, who noted that the sea is mining the dump front and sent this picture.

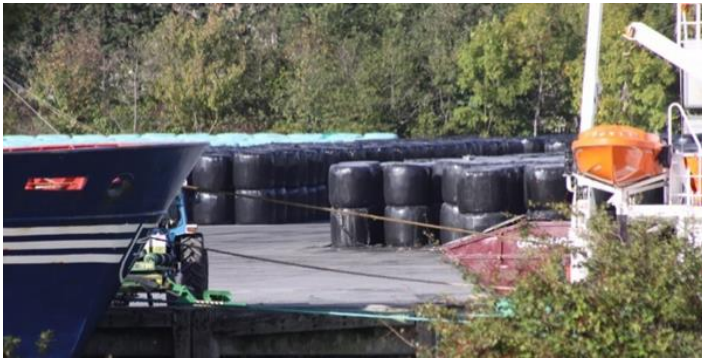
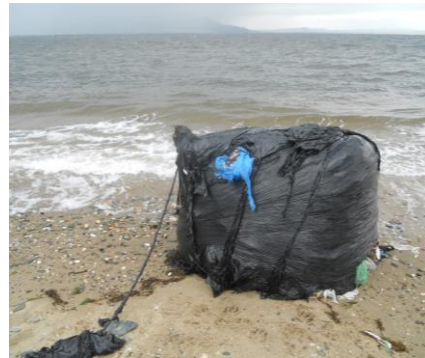
Wrapped waste in Drogheda port (left), photographed during his survey of the opposite bank of the Boyne estuary by Declan Collins. Rubbish bale on Moville beach autumn 2012 survey (right) photographed by Patricia Murphy.

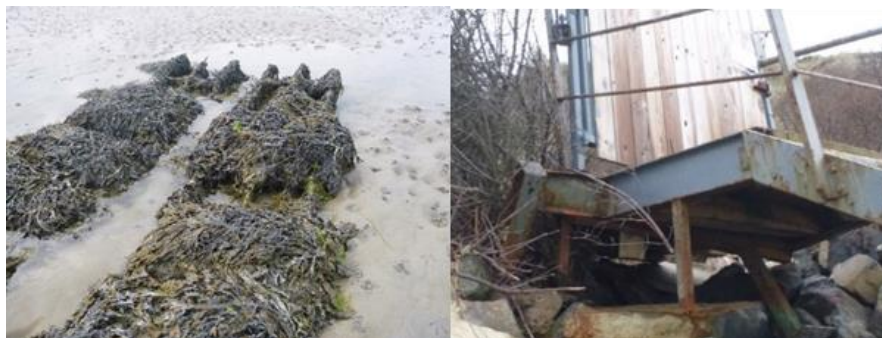
Defunct oyster trestles found in many estuaries and beach access stairs in Co. Wexford. Picture by Surveyor.

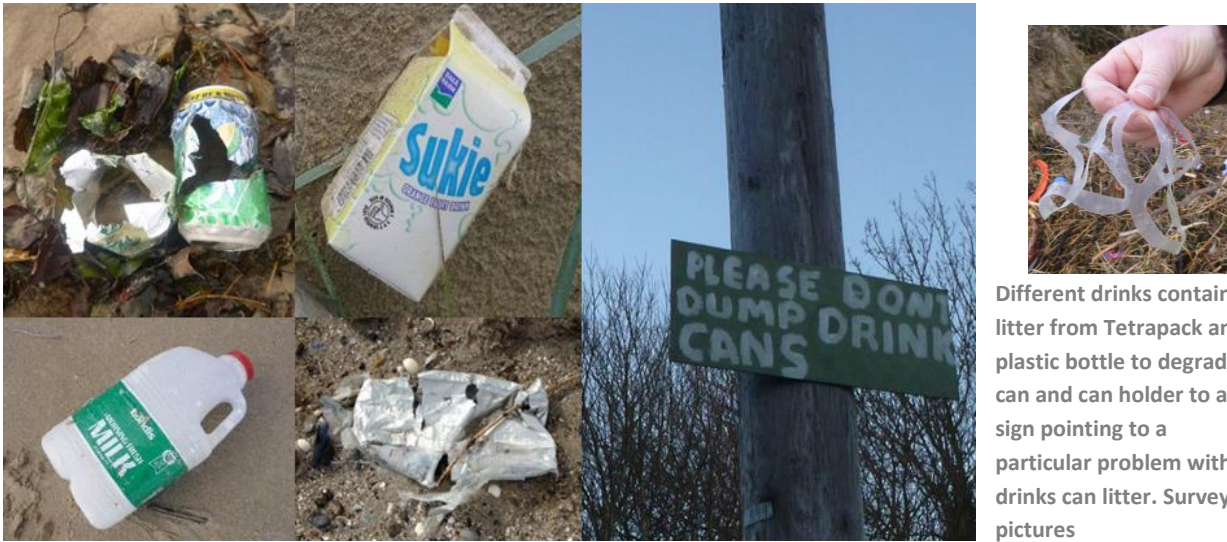
Different drinks container litter from Tetrapack and plastic bottle to degrading can and can holder to a sign pointing to a particular problem with drinks can litter. Surveyor pictures

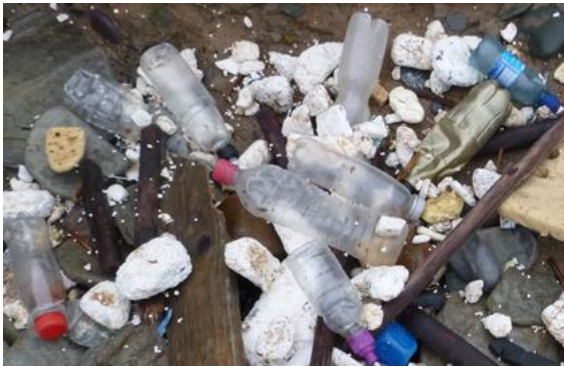
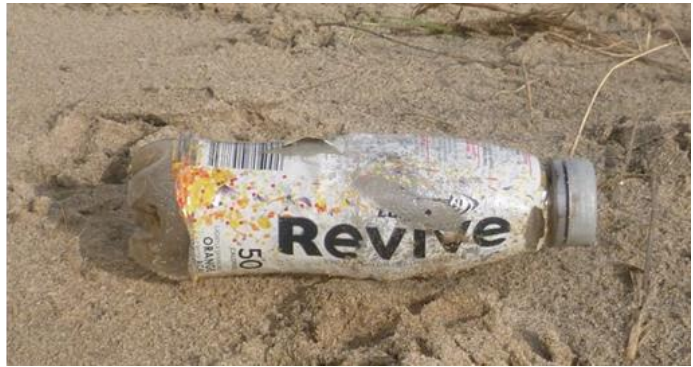
Some bottle clusters are likely to be part of local drinking, while others have spent time in the sea and been washed back onto the shore, piling it up in a small deposition area. Currents and winds can carry the light litter from a wider area and dump it on a given stretch of shore almost as though a sweeping brush had been at sea with the shore as the dustpan. The difference between the drinking spots and sweep area deposit areas tends to be in the other wastes recorded and the high prevalence of closed bottles on the sweep beaches, suggesting that containers without lids fill with water and are less likely to be swept up. A lid count might be a proxy for bottles in the sea.

Plastic bottles on the coast. Picture by surveyor.

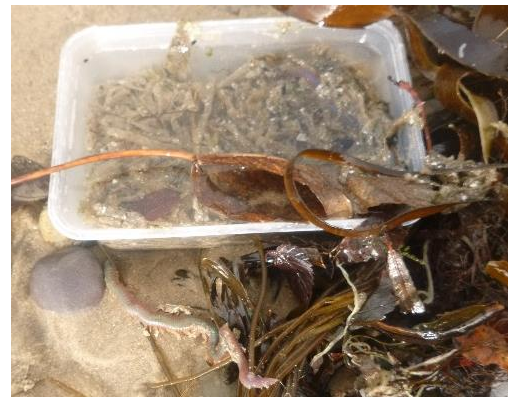
Tackling the residue: this shopping bag litter appears to be associated with locations which have a high drinks container count and with angling waste. Angling litter doubled this year (see page 50) and was more widespread. Bait is sold in plastic boxes which are then placed into plastic bags to go to the shore. Containers and bags may be lost on a windy day – even with lugworm content as this Galway picture shows.

Bait box with last worms escaping

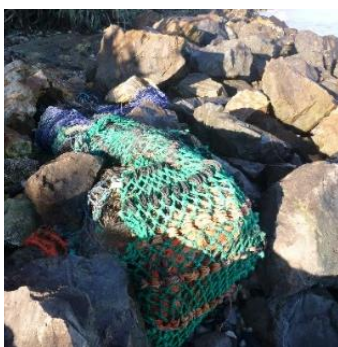
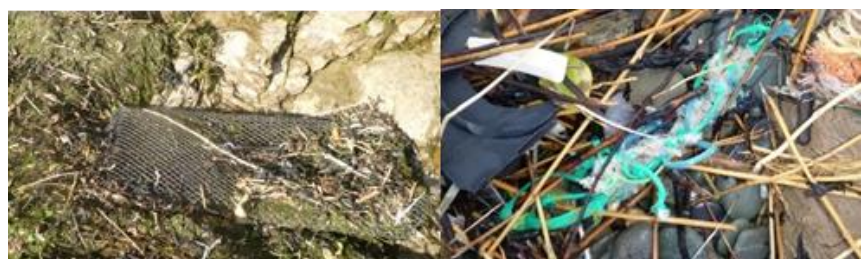
A netlon oyster grow bag and Entangled ropes swept up in Bannow Bay, Co. Wexford. Picture by Alice Michieli.

Some large fishing gear is so heavy that it is still in position on rock armour a year later. Photo Poulshone, Co. Wexford, 2012 Justin Byrne, seen again in 2013.

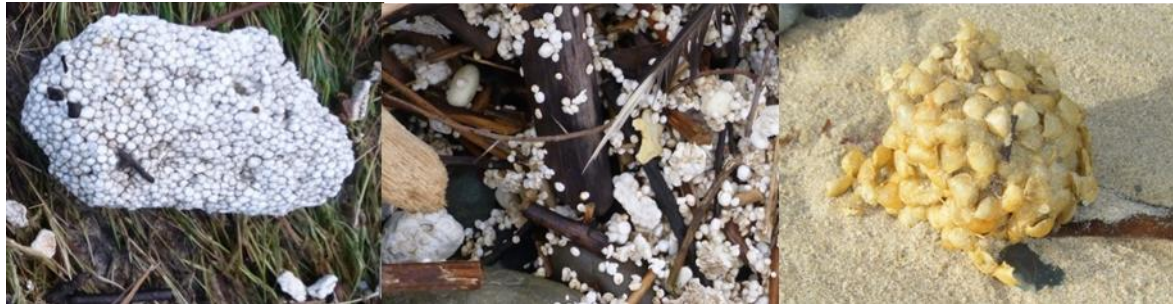
Polystyrene on shores here Clogga Co. Wicklow and broken into small beads by the waves. Picture by surveyor.

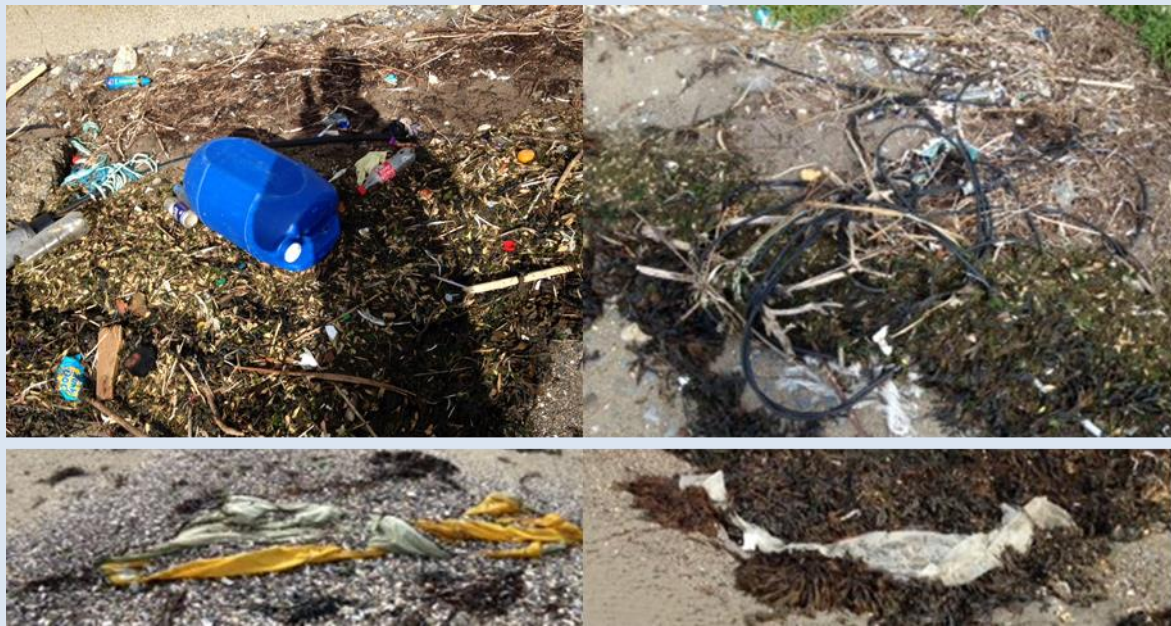
Snapshot of litter problem on Sutton strand which go beyond the usual drinks container litter. Here ‘damage to nature’ litter included suspect container, a lot of lids, piping and straps and large plastic sheeting.

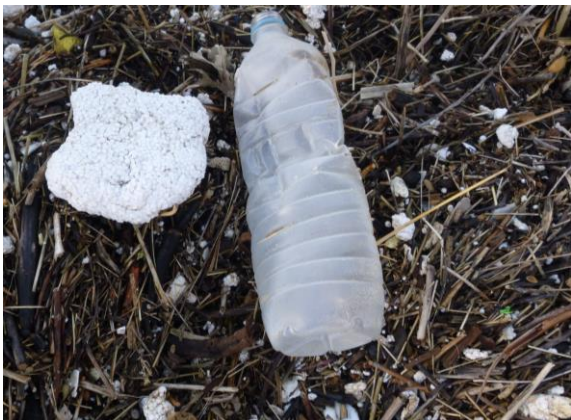
Two litter items at first sight, but > 300 when a 25cm square quadrat of this tide line deposit was examined in more detail.

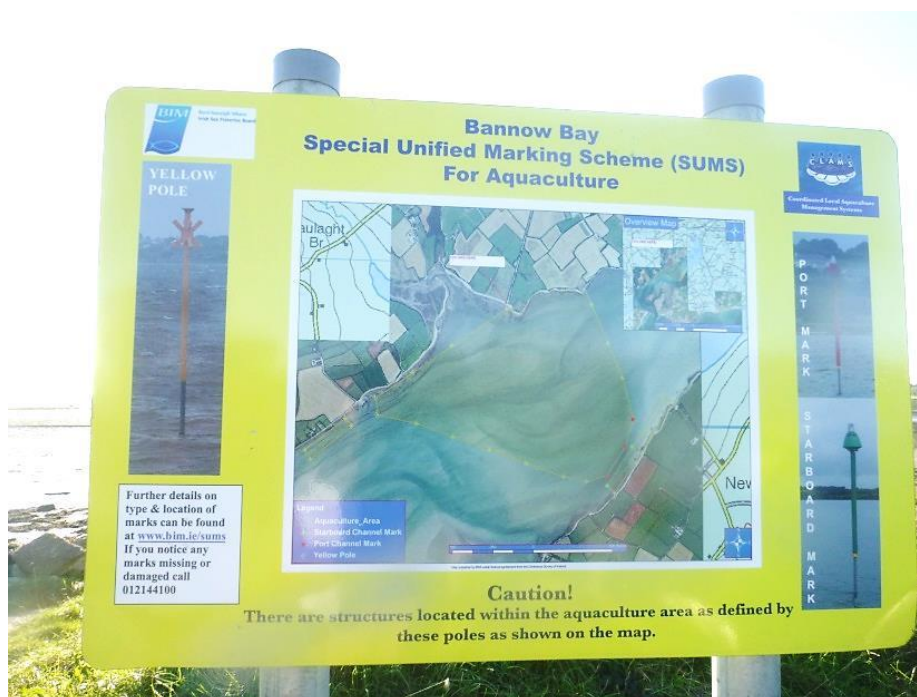
**Shellfish waters** show the biggest shift. In the previous survey 90% didn't know they were in an area designated under the Shellfish Water Directive. This year only 52% failed to identify this designation. This improvement is clearly related to the information signs recently installed by BIM who have come up with another designation – the Special Unified Marking Scheme – which we found under 'other designation' in our results.

Shellfish water information sign. Picture by surveyor.
