COASTWATCH AUTUMN 2019 SURVEY RESULTS

All Ireland Marine Litter

Coastwatch Autumn 2019 Annual Survey Results

As reported by volunteer citizen scientists

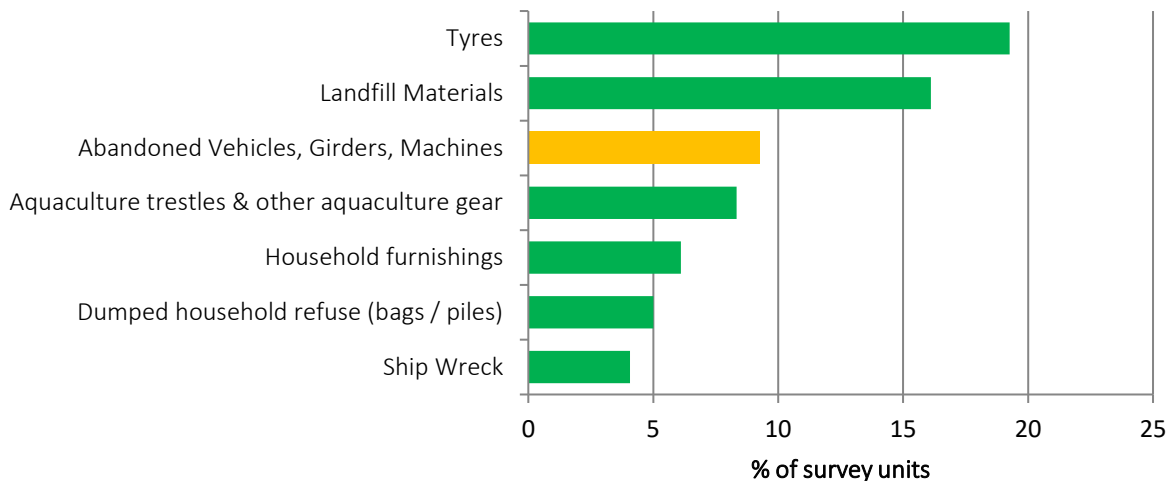
Surveyor reports of large waste show an improvement of 2 or more % for all categories except abandoned machinery, compared to the previous year.

Figure 2. Large Waste recorded on the shore in the autumn 2019 Coastwatch survey expressed as percentage of 500m s.u. with waste. Green indicates a decrease in waste recorded from previous years and orange a slight increase (of <2%).N=540.

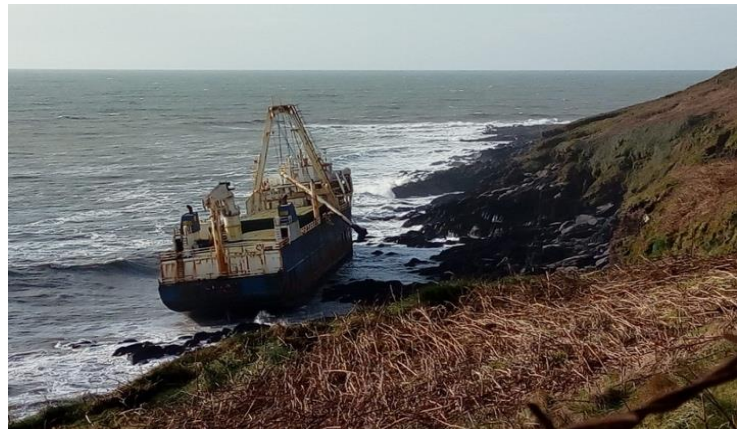
Picture 1. MV Alta Merchant ship stranded on rocks near Ballycotton Feb 16th 2020. Photo Mary Looby

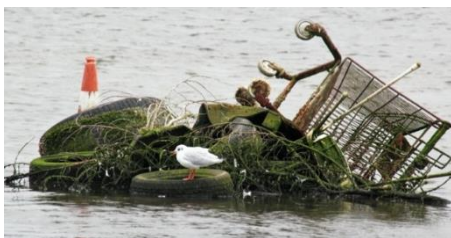
Bags, boxes and even loose heaps of household refuse were recorded in 5% of surveyed sites. This frequently overlaps with areas where household furnishings were recorded and areas where surveyors noted that there was a threat of dumping. The threat map (figure 4) suggests that coastal dumping is worst in inlets. In several site comments and observations from previous years highlight that there is an ongoing dumping problem in one spot or along a short stretch of coast with easy but secluded car access.

Picture 2. Dumped large waste in Inner Malahide estuary. Photo Gemma Hooper.

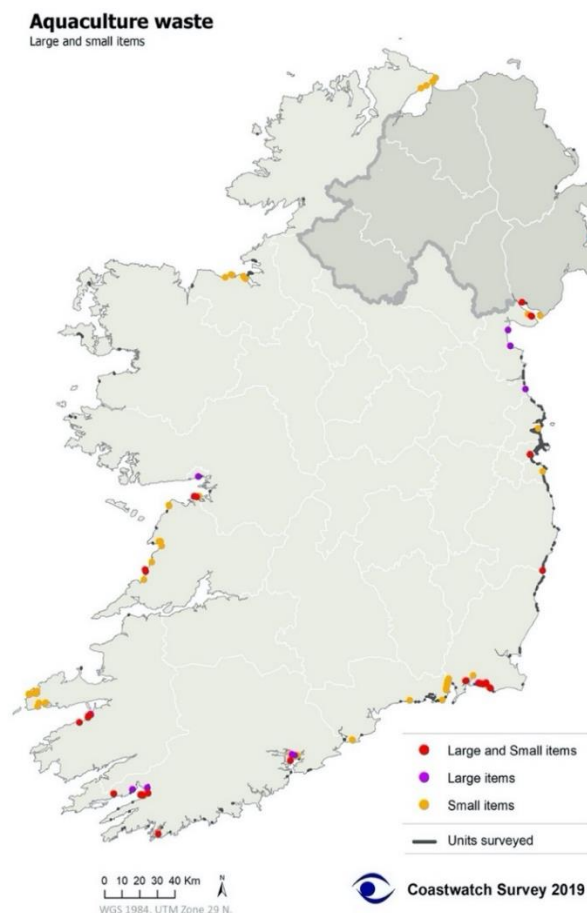
This waste was found in 8.5% of the sites surveyed in 2019. While this appears to be a decrease over the peak year of 2018, GIS mapping of results showed that the 2019 survey does not include several aquaculture areas surveyed previously in 2018 in Cork, Wexford and Donegal. Once that is taken into account there is no improvement. As a general observation, large aquaculture waste typically stays very near to, or in the aquaculture operation areas and is often accompanied by small aquaculture waste – see map figure 6.

Figure 6. Map of Aquaculture Waste- large and small - found on the Shore in the 2019 Coastwatch survey.

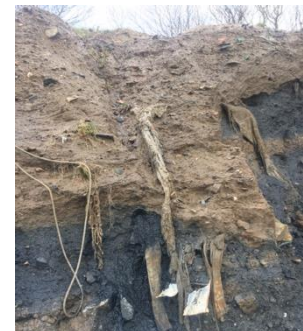
One 2019 oddity being followed up was reported in Courtown harbour, where earth appears to be dredge spoil piled onto land adjacent to the shore the previous year and is now eroding, revealing some waste but also fine harbour silt (see photo).

Picture 3. Sea eroding dredge spoil placed on shore as beneficial reuse. Courtown.

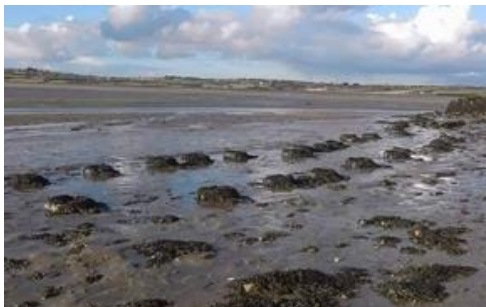
Figure 9. Waste tyre distribution on the shore, grouped as 1-5 tyres, 6-10 tyres and > 10 tyres/su. Coastwatch survey 2019

Tyres were found on 19% of shores and surveyors counted 877 tyres with distribution shown in figure 9. Areas with less than 5 tyres are typically associated with either dumping, or lost boat or harbour fenders. Larger clusters of tyres are strongly related to areas where they are placed in lines into the intertidal close to seaweed as shown in photo below. This is to catch peeler crabs for sale. None of these tyre traps are authorised. Most are in Natura 2000 sites.

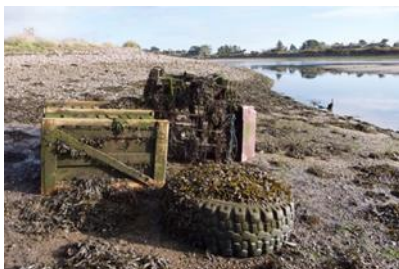
Picture 4. Photo of Tractor tyre and other gear in Castlemain harbour protected site.

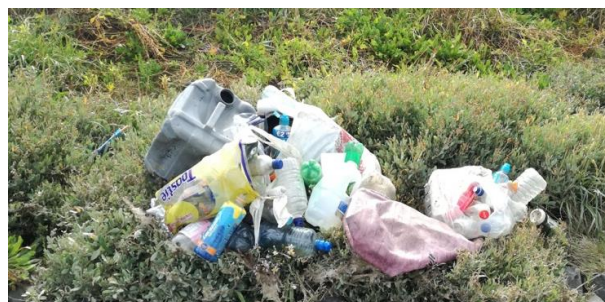
Picture 6. Drinks container litter

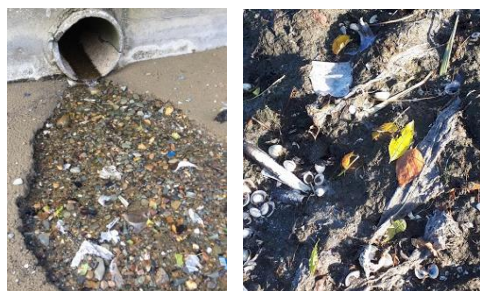
Picture 8.: (L) pipe has spewed sewage including wet wipes into a shellfish rich area and (R) wet wipes mixed with green algae on a bathing beach.

The state of our small inflows as carriers of sewage has also disapproved. There is growing evidence that wet wipes play a key role in this deterioration. Action options are presented in the Coastwatch recommendations document – www.coastwatch.com.

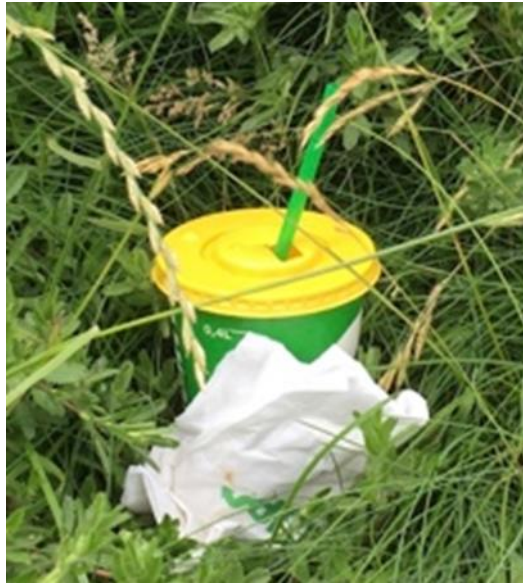
Picture 11. single use cup with lid and straw as well as food wrapper all carefully placed just at the beach entrance about 20 m from a bin.

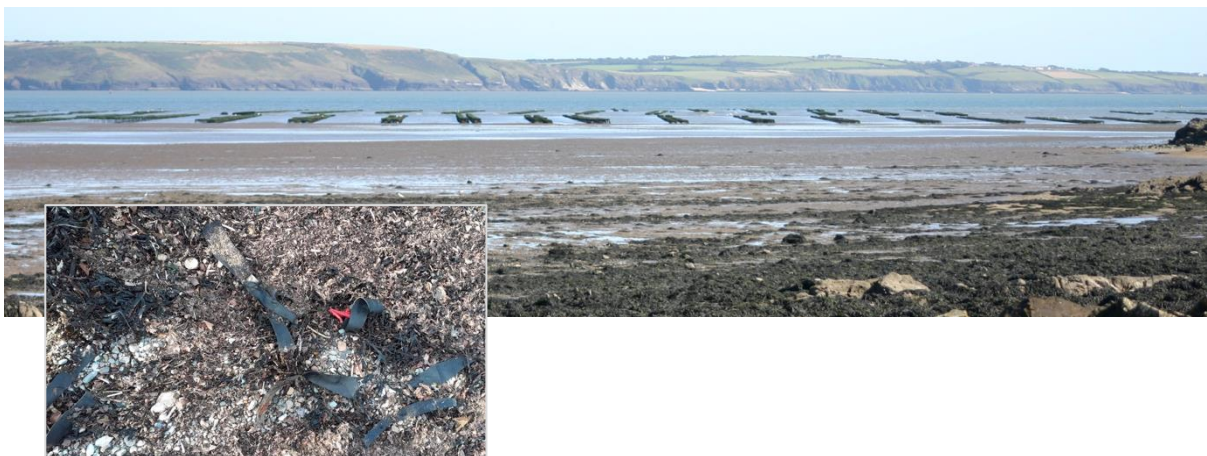
The 2019 reduction in aquaculture areas covered, is likely to be the reason for a slight reduction in aquaculture waste. The GIS maps highlight this shift. Dungarvan spit, Woodstown beach Waterford and Lough Foyle Donegal coast - known as aquaculture litter hotspots in the past - were badly littered once more from surveyor comments. Metal hooks, rubber gloves, netlon bags and rubber with hooks are typical for areas of trestle grown Gigas oysters.

Picture 12. Photo of Gigas aquaculture in the low intertidal and sublittoral with trestle ties washed up on the shore.

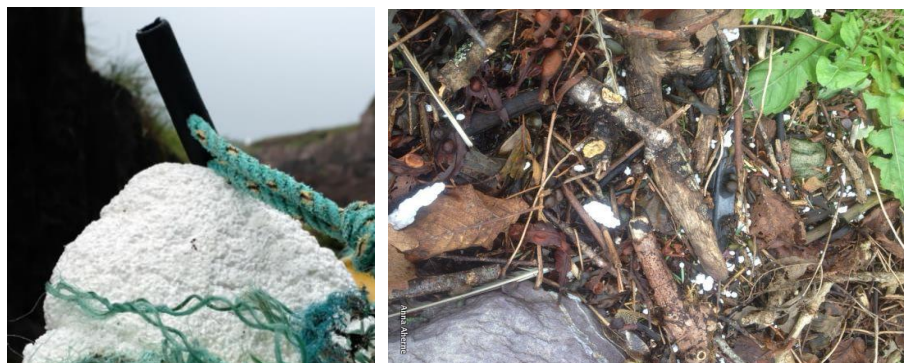
Picture 13. Photos of Polystyrene block and pieces, breaking down to beads – bite size for birds to pick up.
